> Seismic retrofitting of structures

Strategies and collection of examples in Switzerland

Wenk T. 2008: Seismic retrofitting of structures. Strategies and
collection of examples in Switzerland. Environmental studies No. 0832.
Federal Office for the Environment, Bern. 84 pp.

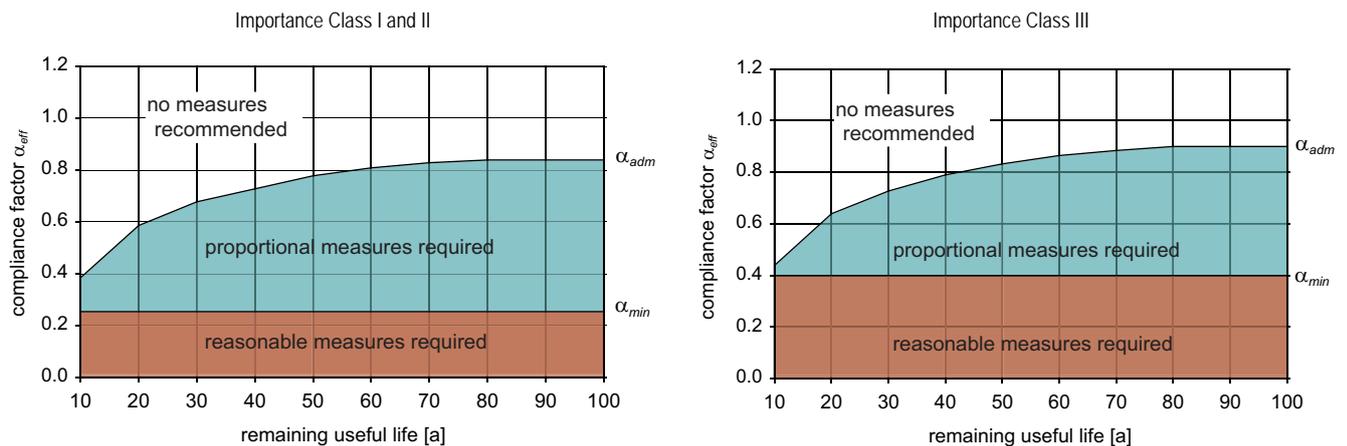
Fig. 5 > Recommendations of measures according to Pre-Standard SIA 2018

Necessity for measures of seismic retrofitting for importance classes I and II (left) and importance class III (right) as a function of compliance factor α_{eff} and the remaining useful life of the building according to SIA 2018.

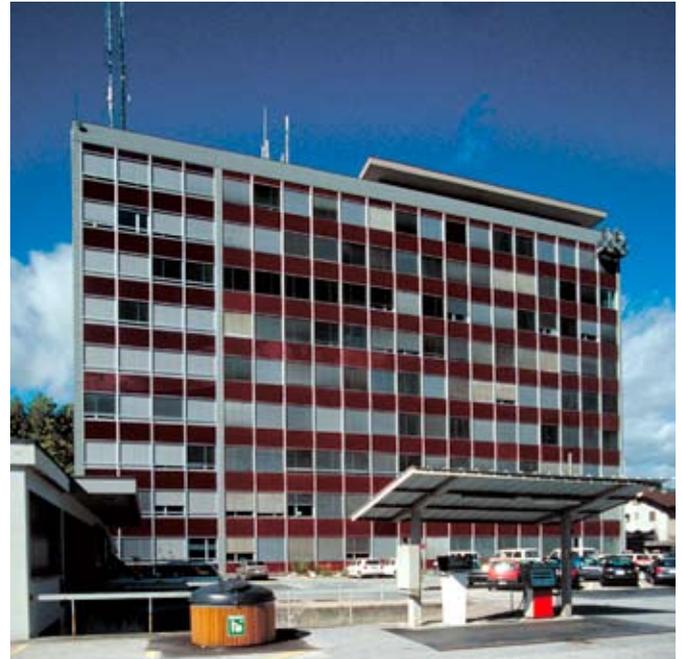
View of the longitudinal facade. The four, leftmost windows at each level are part of the extension.

The existing building will be improved by the construction of an extension, which will provide horizontal support for seismic action. The choice of I-shaped reinforced concrete walls within the new extension reduces the torsional eccentricity on the entire system. The transverse stiffness of the new walls can be kept small compared to its longitudinal stiffness. The new extension is connected to the old part of the building through the installation of post-tensioned strands at every slab level in the longitudinal direction. The unreinforced masonry walls in the emergency command centre are separated from the structural system by joints and coated with polyester fabric,

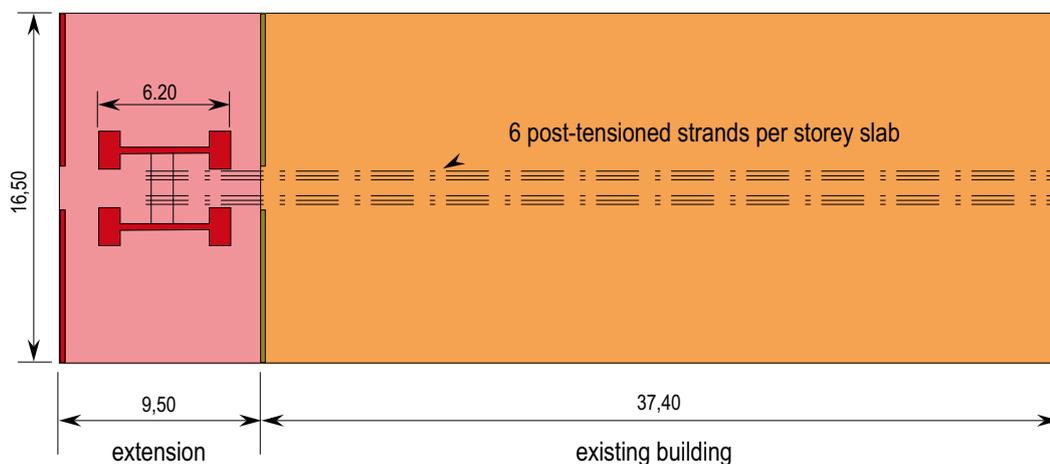
Floor plan of the existing building (right) and the extension added afterwards (left) through which two I-shaped reinforced concrete walls provide bracing.

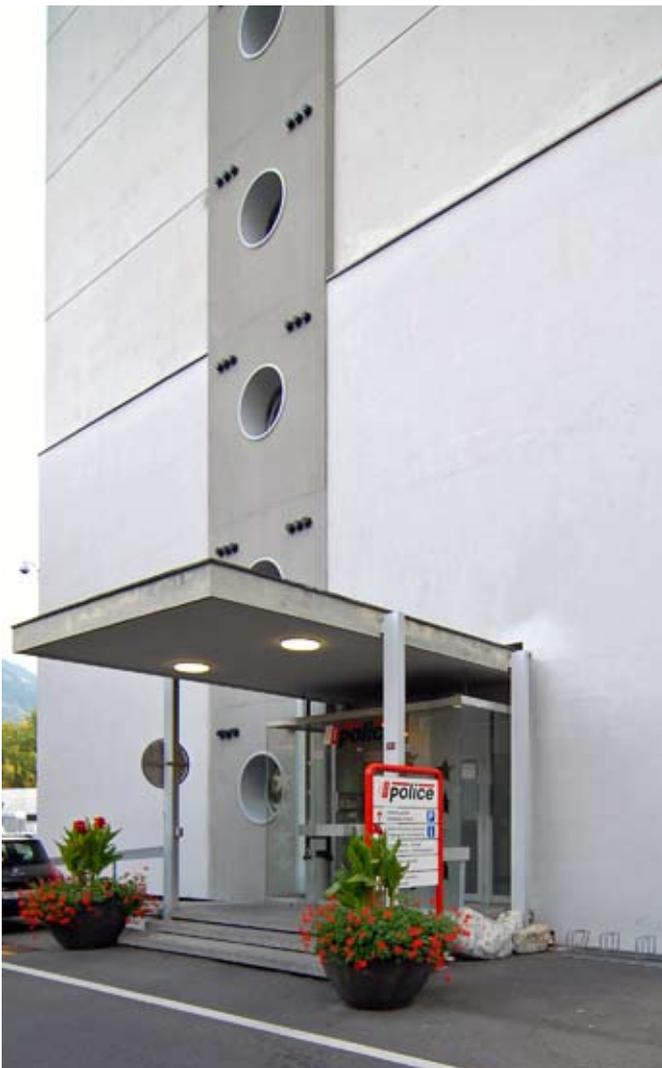
Transverse facade of the existing building showing the anchorages of the tension strands visible on the outside at each storey level.

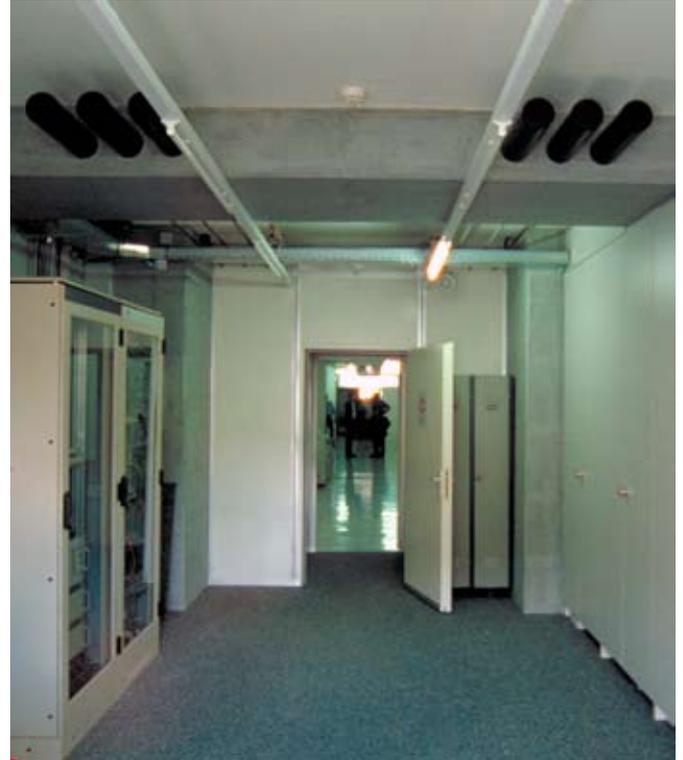
View of the 6 anchorages of the tension strands in the cross girders between both new I-shaped reinforced concrete walls in the extension.

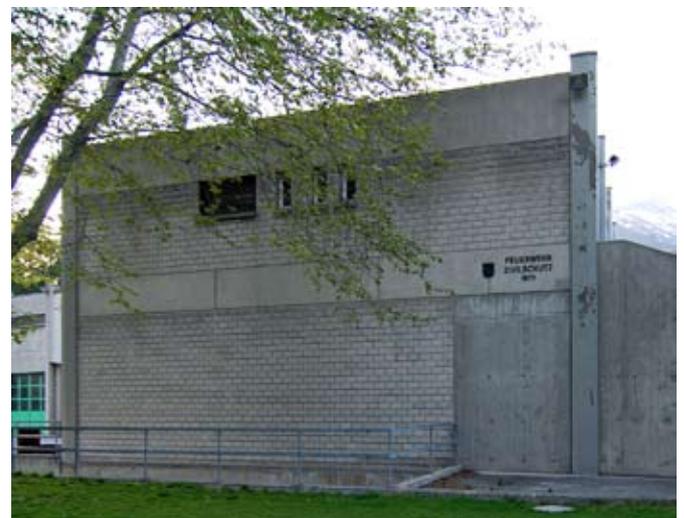
The masonry gable wall strengthened by vertical CFRP-strips.

horizontal deformations respecting the damage limitation criteria for a building of importance class IC III. In addition, the post-tensioned CFRP-strips prevent the out of plane toppling of the wall.

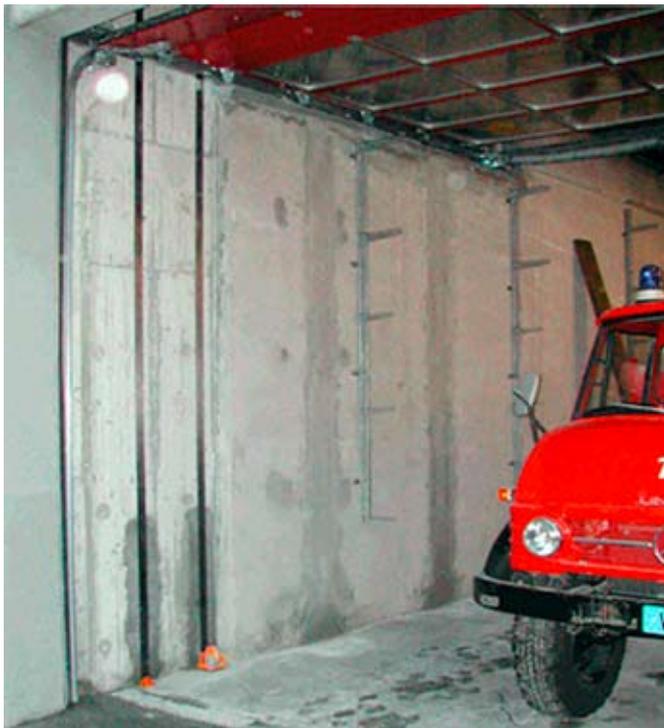
Two post-tensioned CFRP-strips on the inside of the gable wall (Truffer et al. 2004).

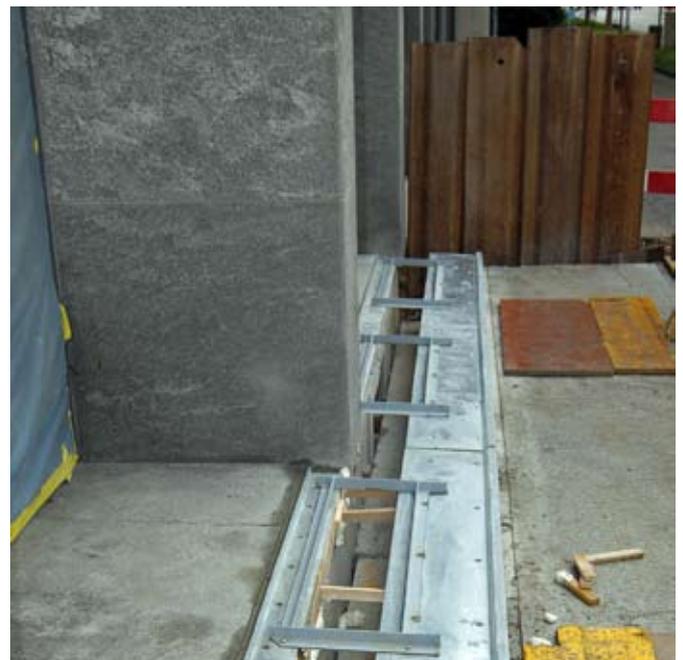
An expansion joint was installed around the building to permit the free, horizontal movement on the new seismic isolation bearings.

The relatively thin columns on the ground floor between the garage doors create a typical soft storey. A relatively weak earthquake would cause failure of the columns. In addition, the walls and floors of the higher storeys are inadequate to carry the seismic forces (Bachmann 2007a).

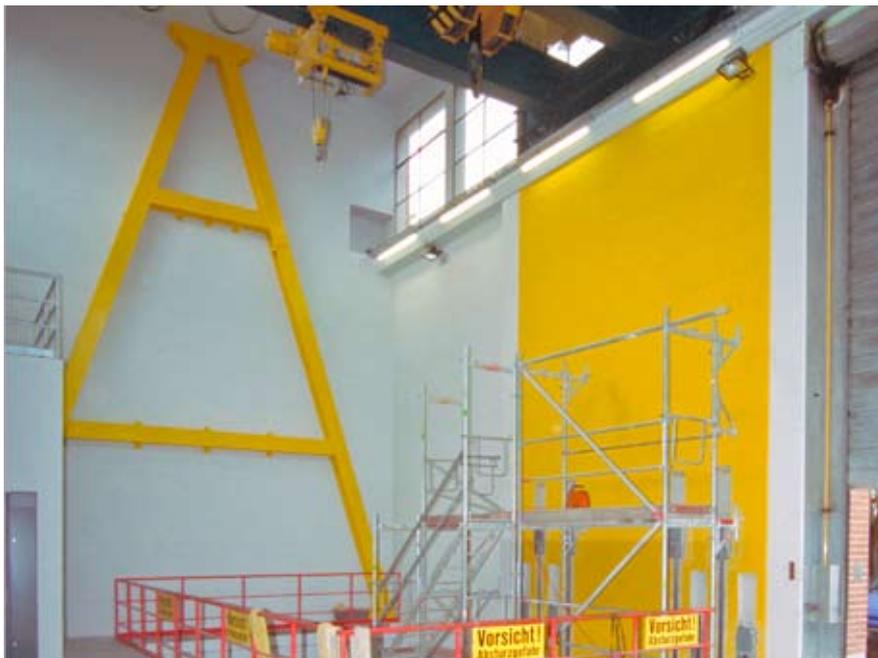
New A-shaped steel frame on the west facade and new reinforced concrete structural wall on the north facade of the assembly shop.

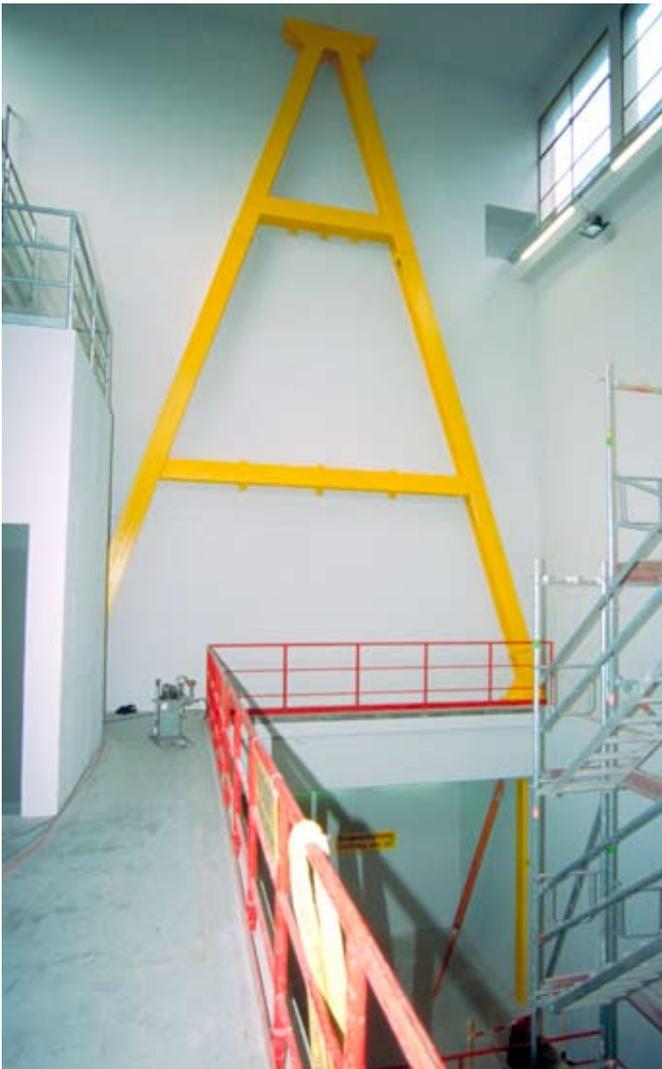
New A-shaped steel frame in the ground floor level of the west facade and new steel plates in the basement.

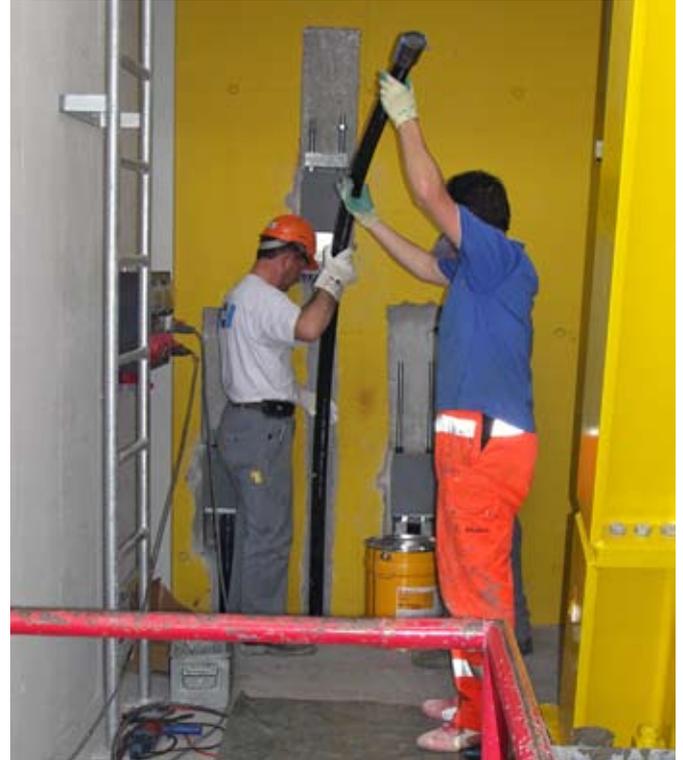
Threading of the CFRP-strips to the anchorage of the new reinforced concrete structural wall.

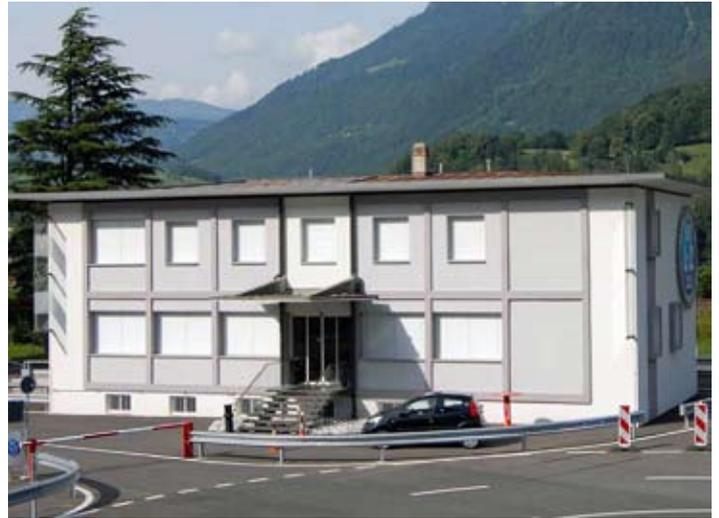
The longitudinal facades are most problematic. At the ground floor the masonry wingwalls are shortened with half of the storey height unbraced and free to oscillate. There is danger of brittle shearing failure even from a weak earthquake.

View of the front longitudinal facade with the new reinforced concrete structural wall on the outside panel at the far right.

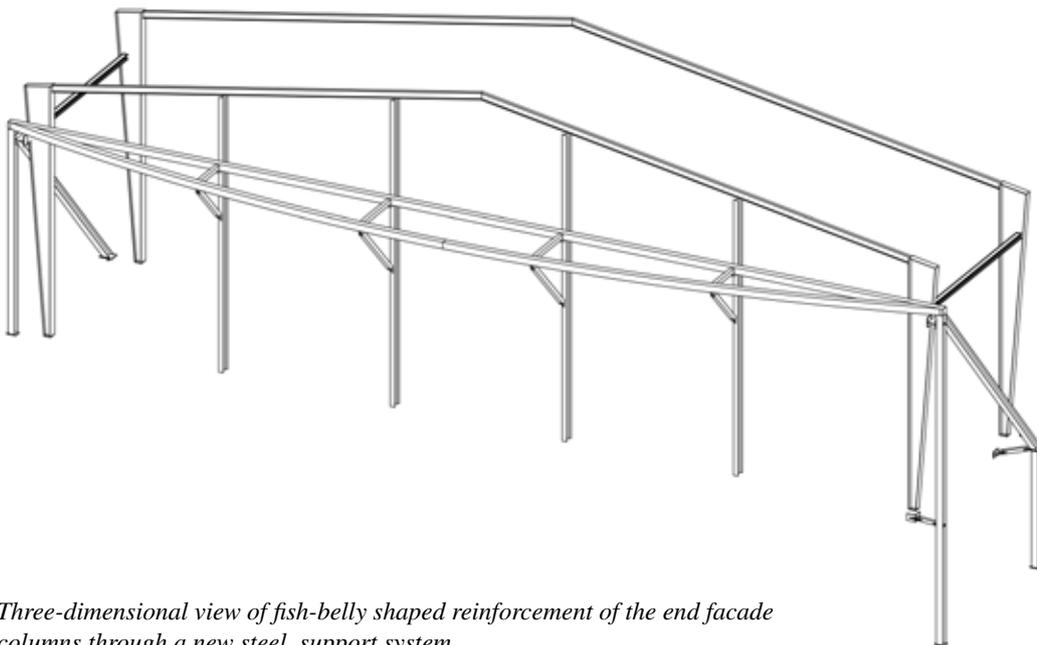
The main problem is due to wind and earthquake in the longitudinal direction of the hall. The horizontal truss in the roof of the hall shows constructional deficiencies in the connection design. In addition, the horizontal bracing of the two-hinged frame in the longitudinal direction of the hall is insufficient. In the transverse direction the ultimate resistance of a strong, 10 m high steel frame is sufficient for wind and earthquake. The steel frame remains in the elastic region under the seismic action of zone Z2.

Three-dimensional view of fish-belly shaped reinforcement of the end facade columns through a new steel support system.

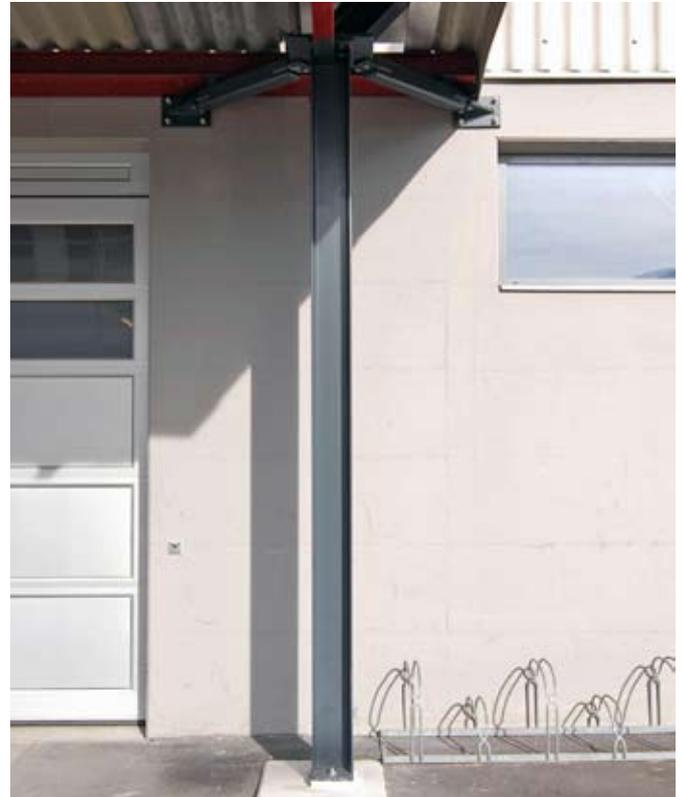
Edge column of the fish-belly shaped reinforcement of the lower storey.

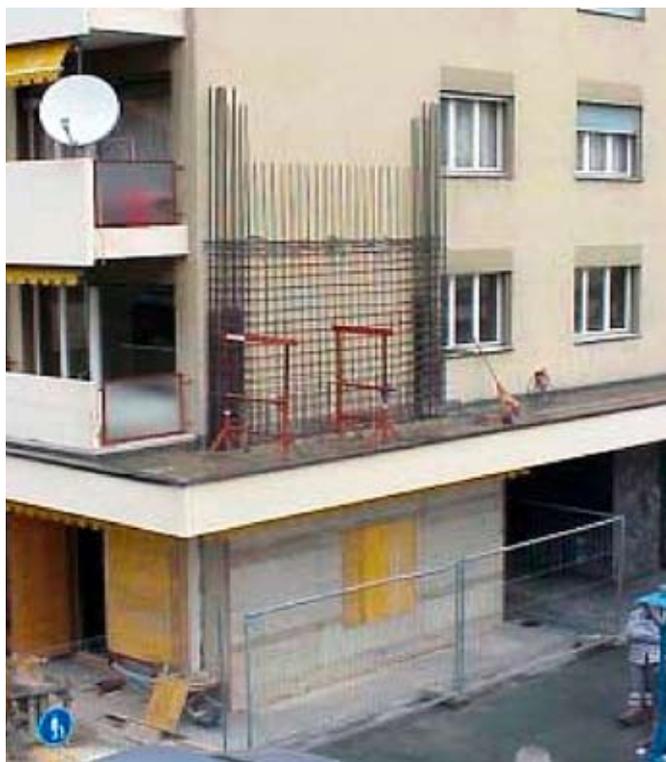
In its original state, the building has a typical, horizontally weak ground level (soft storey). This is due to the transition from masonry walls in the residential regions of the upper storeys to reinforced concrete columns in the shopping center. The structural weakness referring to seismic performance are the columns in the ground floor and especially the insufficient reinforcement in the beam to column connections. In addition, a few masonry walls have insufficient structural capacity.

New external reinforced concrete structural wall will be concreted against the existing facade (Lateltin 2003).

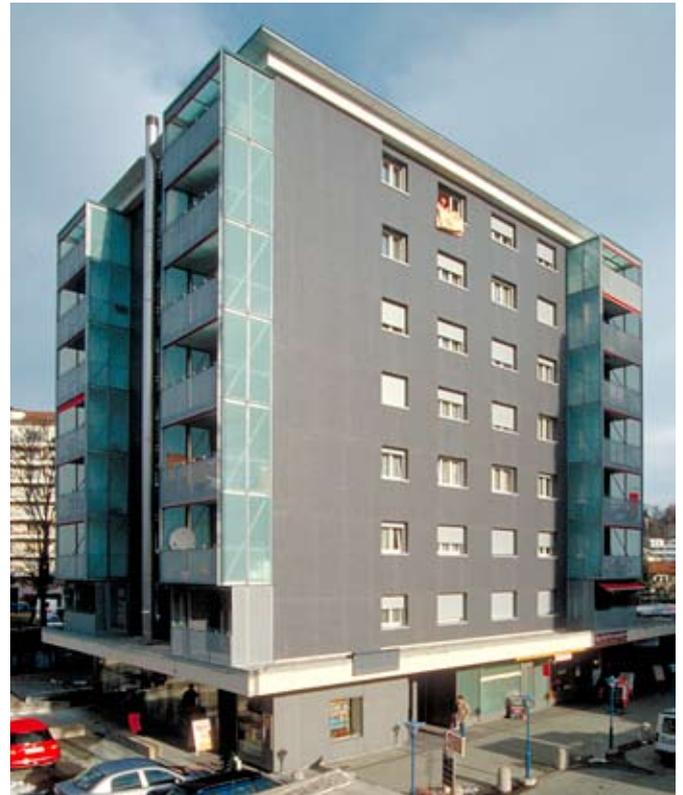
View of the new external reinforced concrete structural wall.

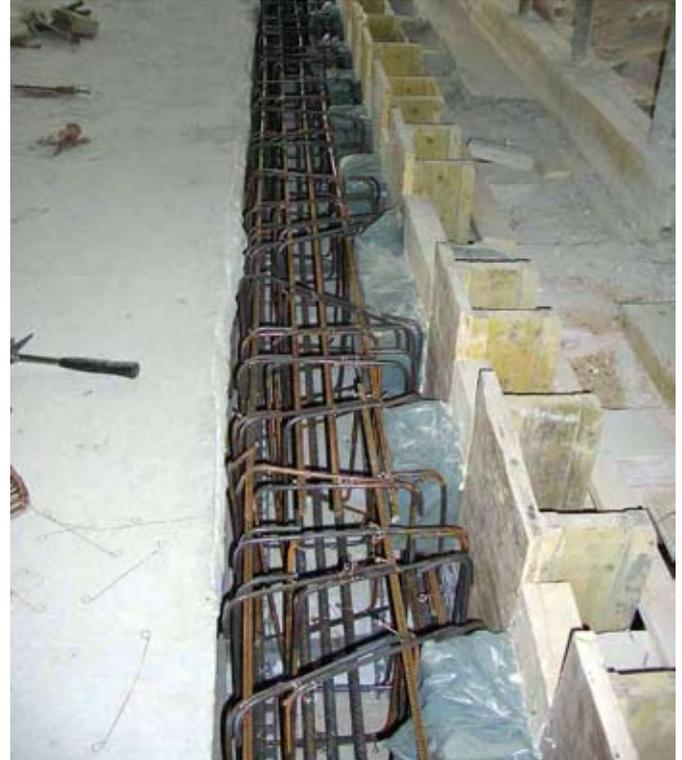
Anchorage reinforcement of the new floor in the masonry walls.

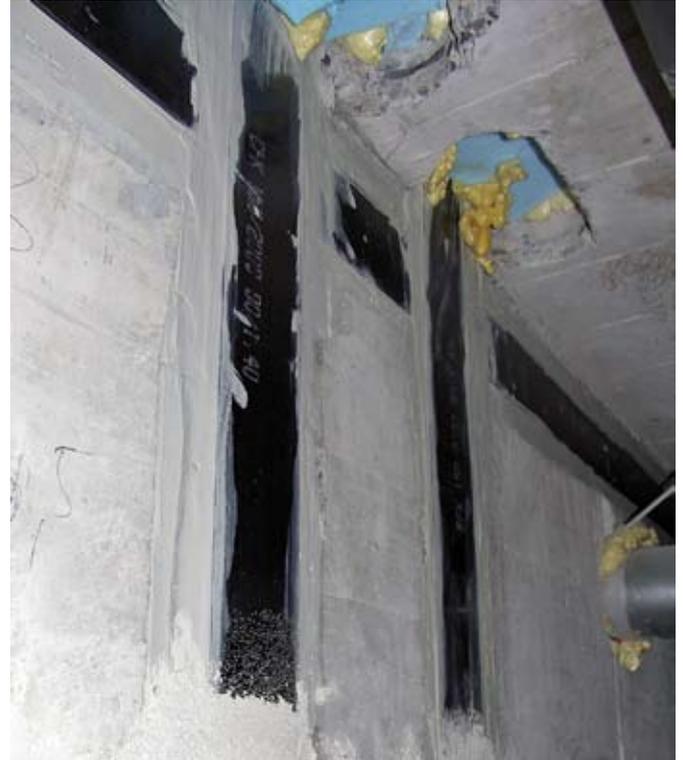
Strengthening of the elevator shafts with bonded carbon fiber strips.

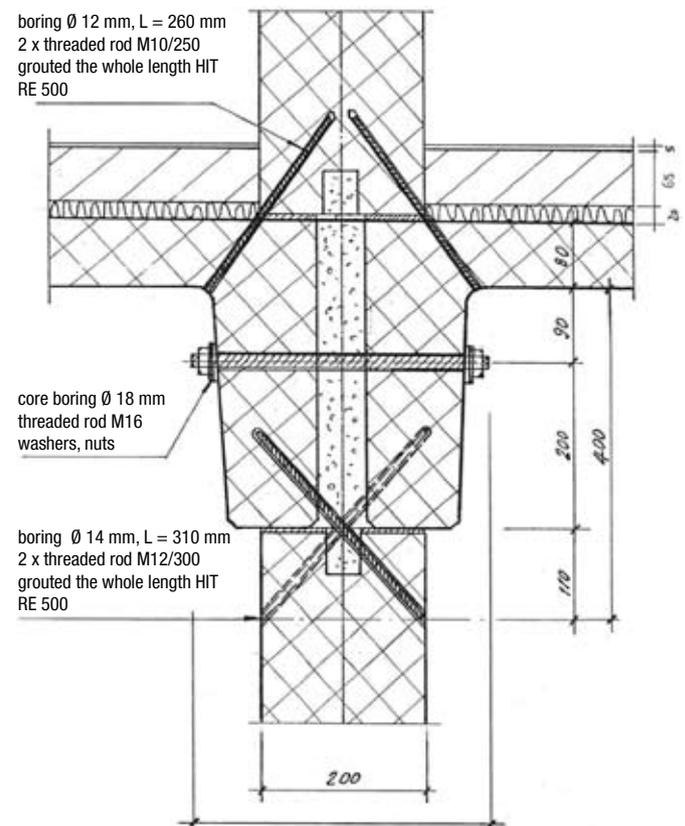
Cut through the modification of the coffer slab showing the new structural components.

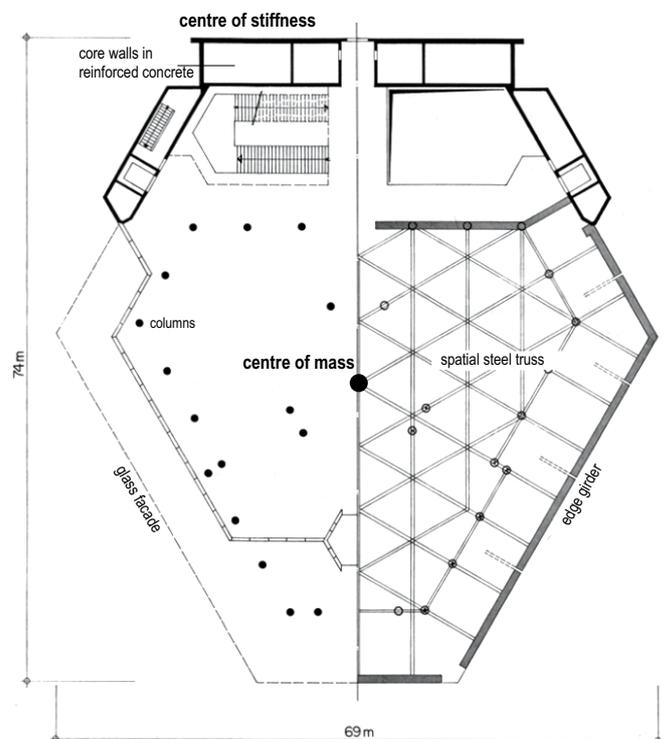
Floor plan through the ground floor level (left) and through the hollow space of the support floor (right) with the locations of the centres of mass and stiffness in the initial state before the retrofitting (Schefer, Zwicky, Santschi 1995).

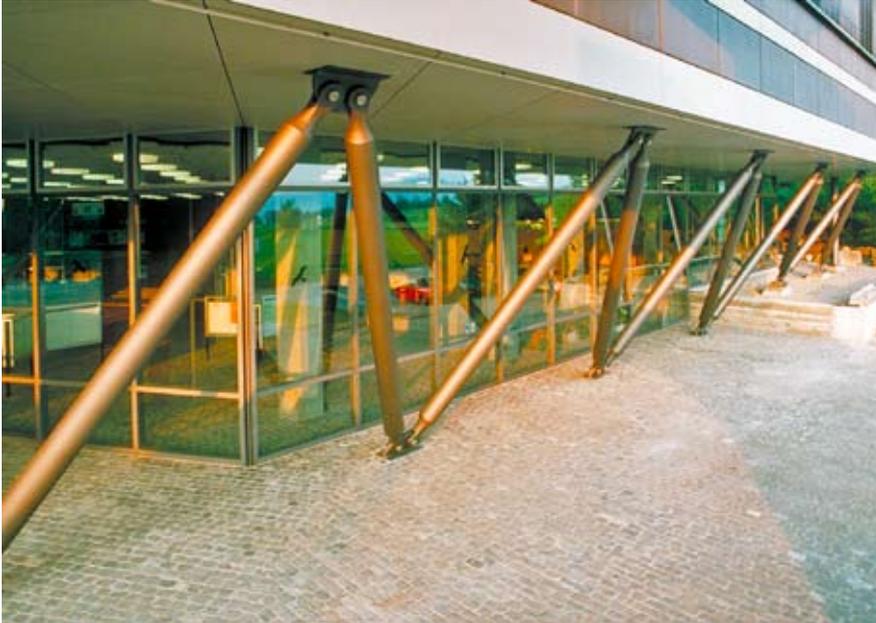
The weak ground floor level was retrofitted with a new, inclined, steel pipe truss. In this way, stiffness and resistance could be increased and the unfavorable eccentricity of the bracing system in the ground floor level could be eliminated.

New inclined steel pipe truss in the ground floor level.

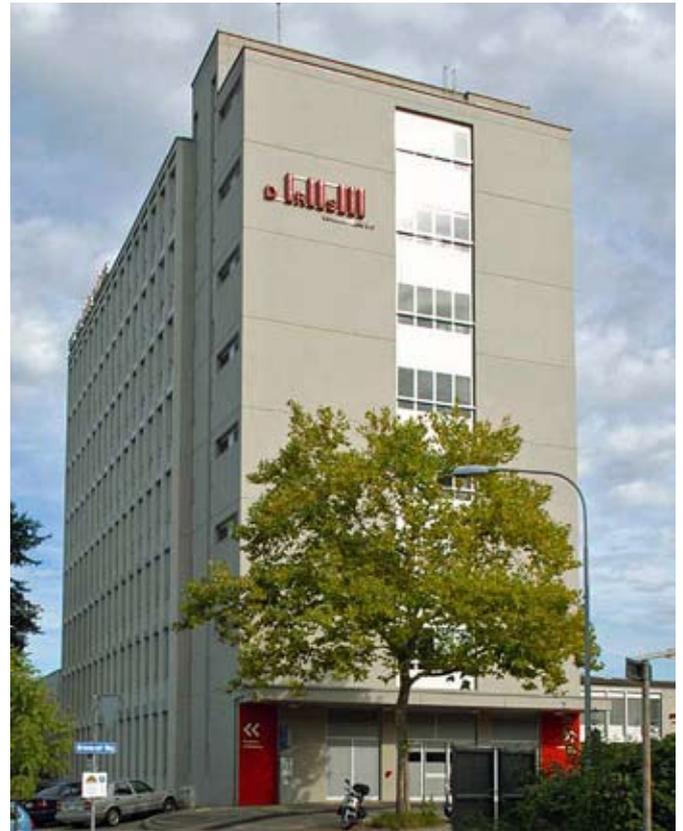
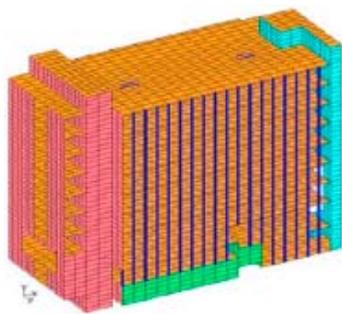
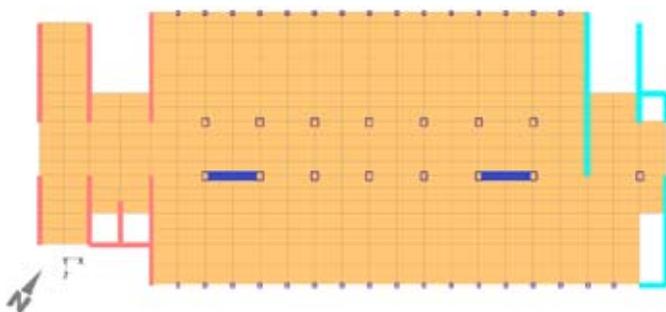
Finite element model for the examination of the seismic safety of the building (above), floor plan with existing reinforced concrete support walls and new steel frames (dark blue, below).

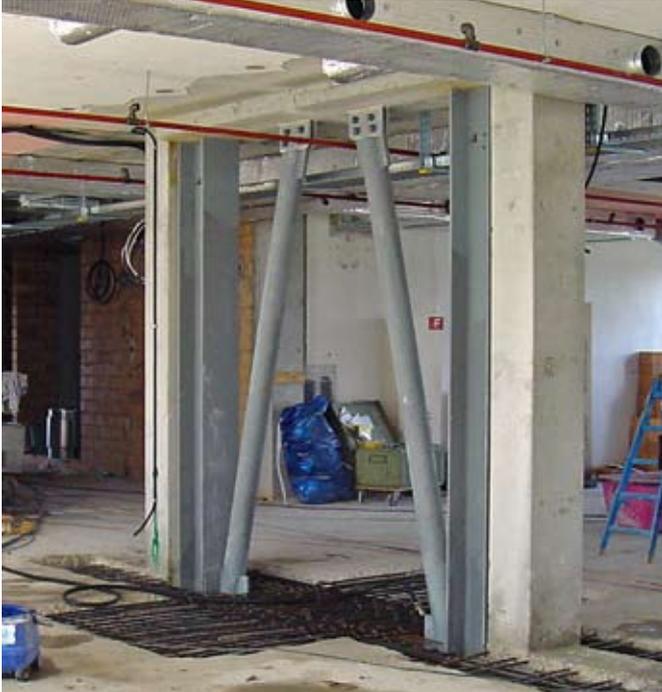
New eccentric steel framework constructed between two existing reinforced concrete columns.

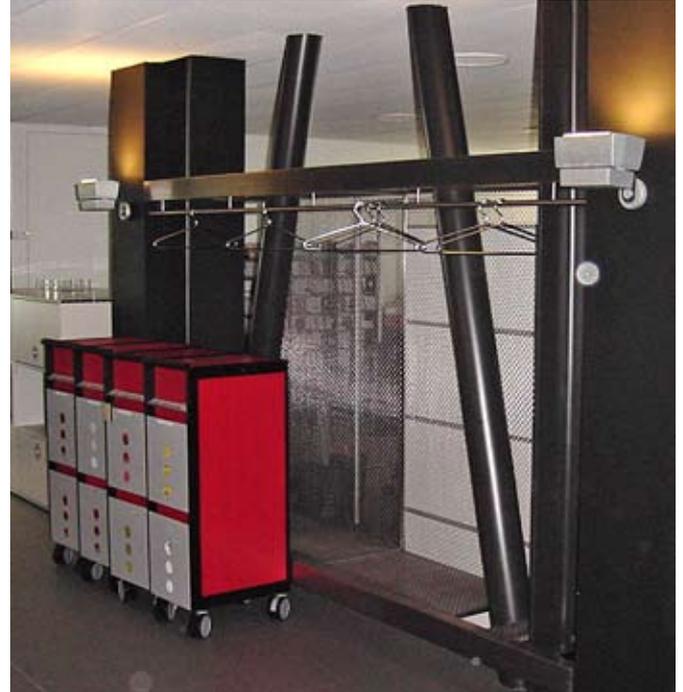
New eccentric steel framework with a column disguise.

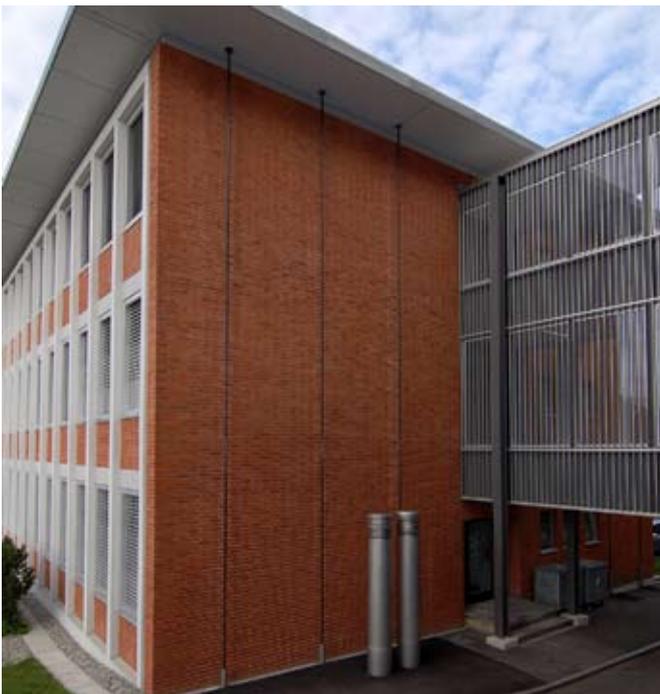
Northern end facade strengthened by external vertical carbon fiber tension rods.

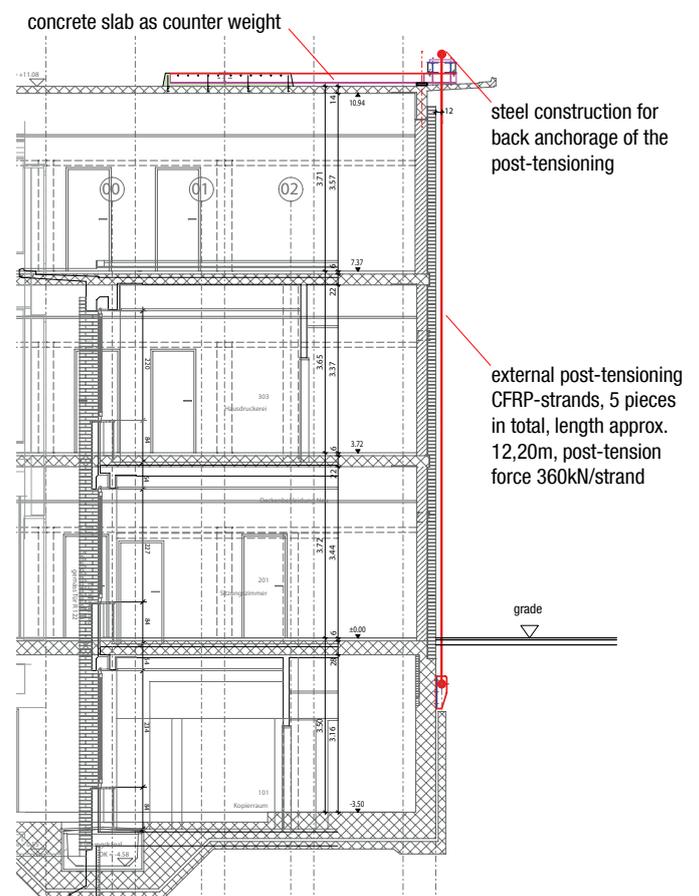
Longitudinal cut through the northern end facade with external carbon fiber tension rod.

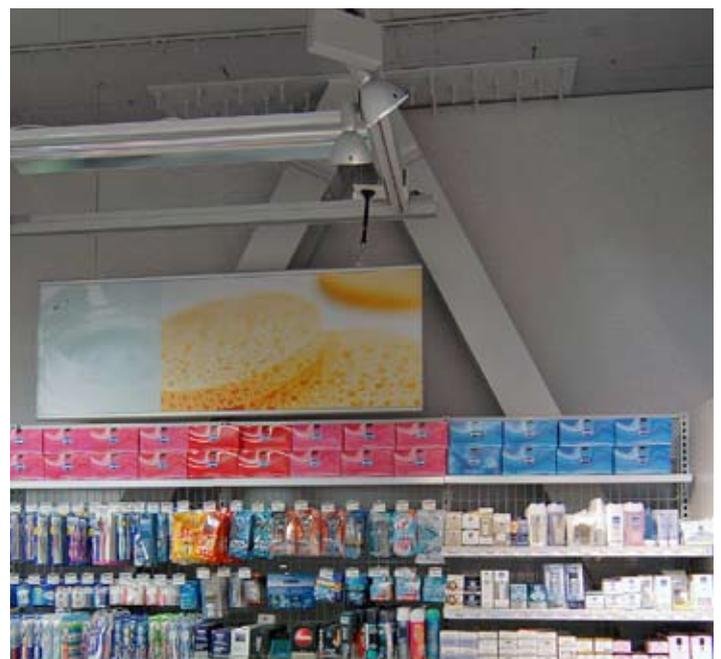
New V-shaped steel truss hidden behind a shopping aisle shelf in the ground floor.

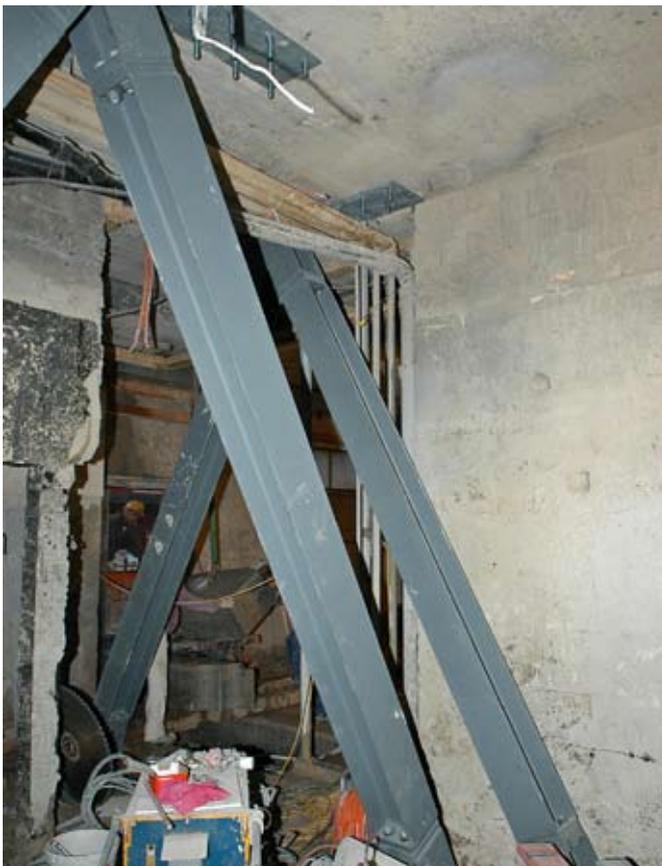
Installation of the new V-shaped steel truss in the ground floor level.

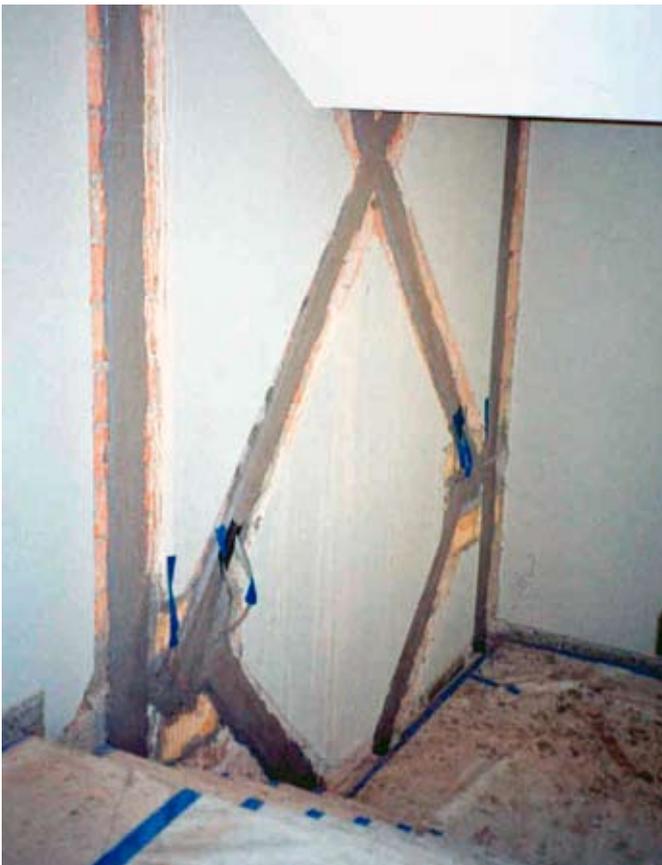
Strengthening of the masonry walls in the staircase with CFRP-strips.

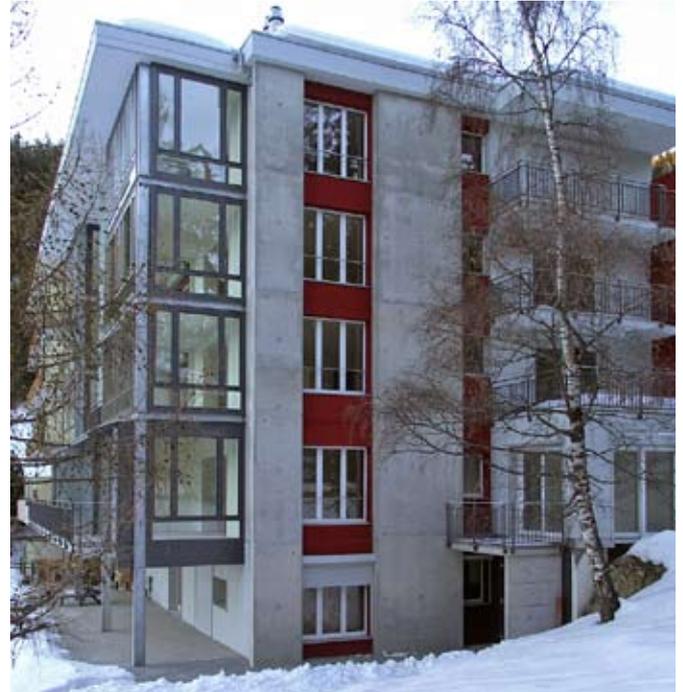
View of the east facade with the new reinforced concrete walls.

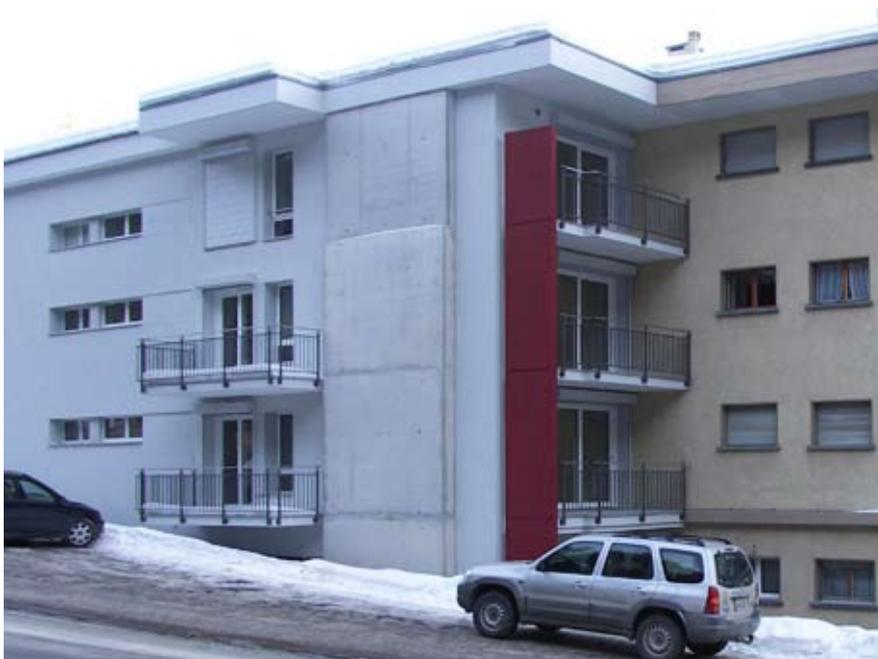
View of the north facade with a new outside reinforced concrete wall.

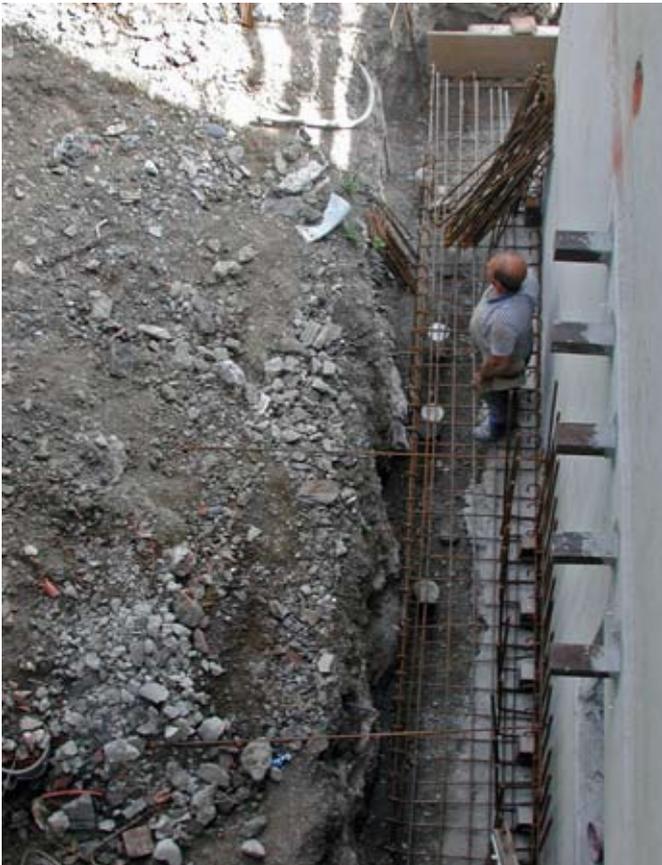
Foundation of new reinforced concrete walls.

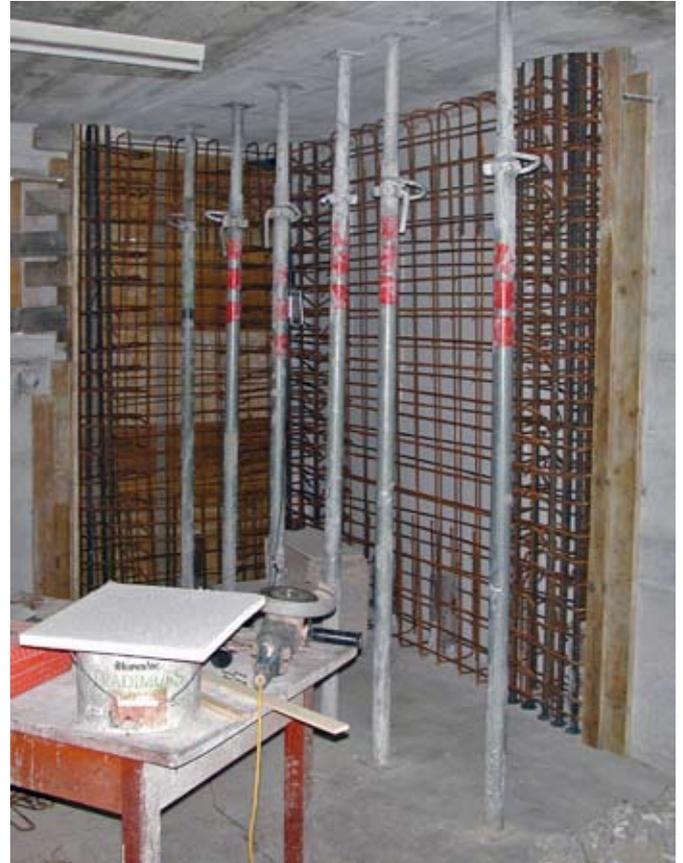
Reinforcement of a new reinforced concrete wall in the basement.

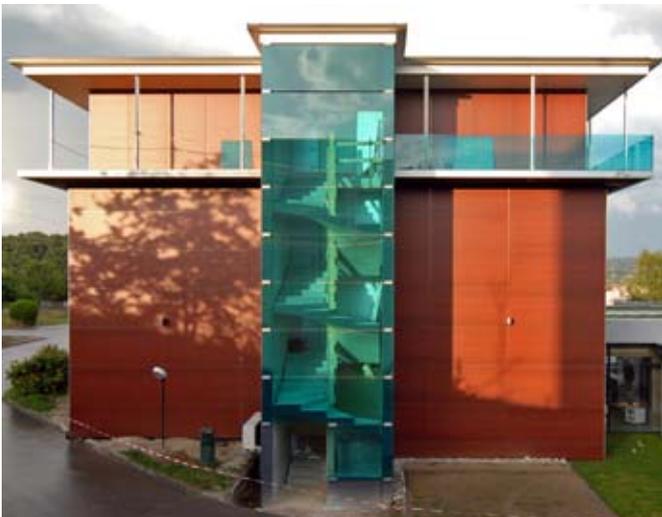
Originally the building had no bracing system in its longitudinal direction, whether for wind or for earthquake. In addition, the subdivision of the building into four compartments through expansion joints, which ran the whole height of the building, resulted in an unfavorable seismic behavior. Furthermore, the suspension of heavy facade elements made of prefabricated concrete was inadequate. In the building's transverse direction, sufficient walls rest on strip foundations.

End facade on the north side with the new staircase out of reinforced concrete.

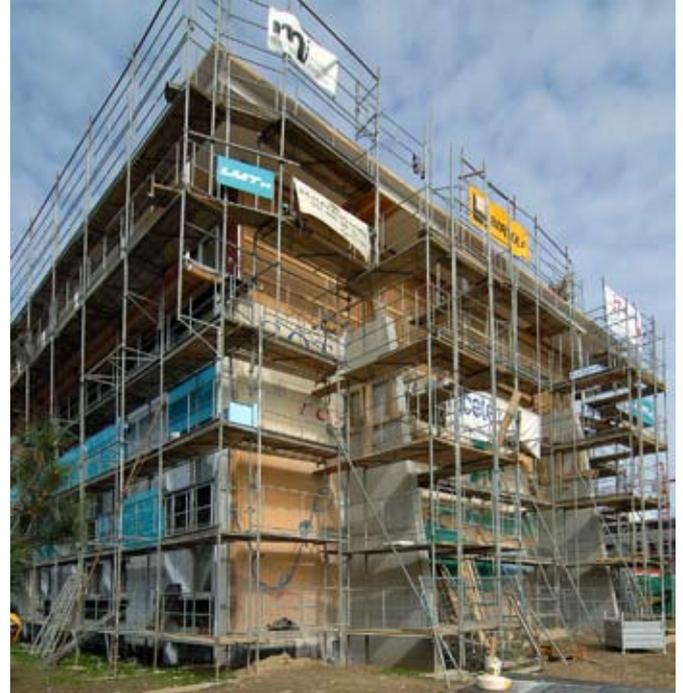
Both new triangular reinforced concrete walls on the south side under construction.

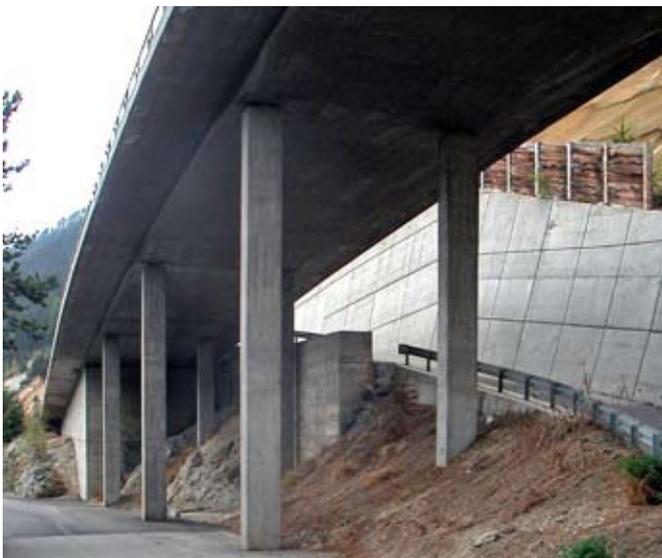
In its initial state, the fixed longitudinal bearings at the abutments of each half of the bridge cannot carry by far the seismic forces. The large variation in column heights causes an irregular distribution of transverse stiffness with the result that the very short columns are overstressed in the transverse direction. Furthermore, there is danger of span unseating in the longitudinal direction at the expansion joint of the intermediate column.

View of a portion of the bridge with tall slender columns.

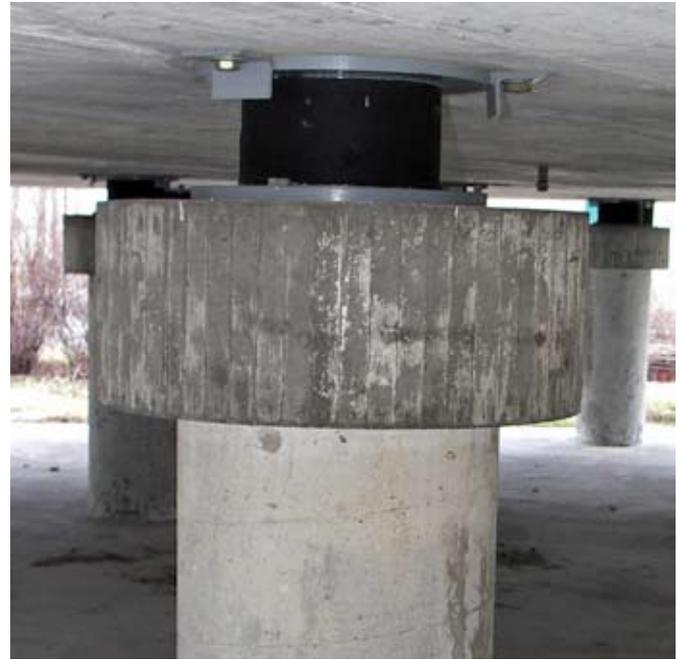
Retrofit by installation of rubber bearings under the liquid gas storage tank.

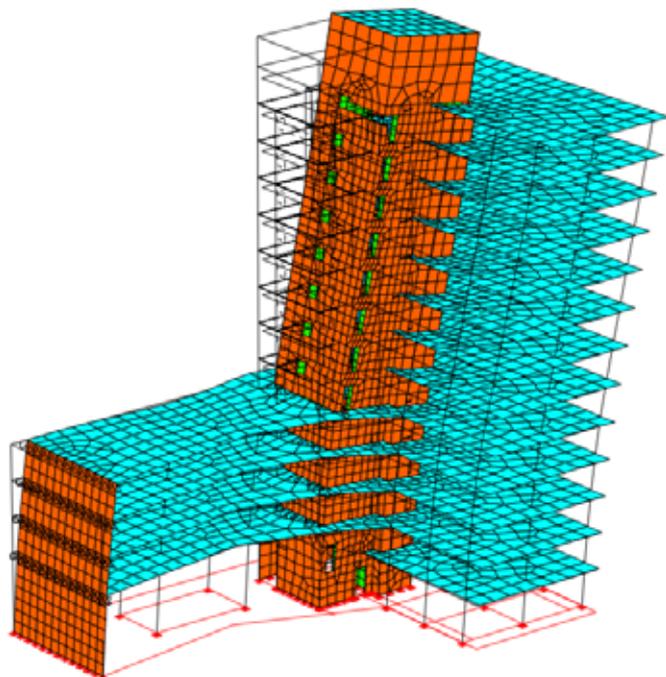
Three-dimensional finite element model for the response spectrum analysis.
