## **Analysis of Existing Rockfall Embankments of Switzerland (AERES)**

### **Part C: Small-scale experiments**

**Commissioned by the Federal Office for the Environment (FOEN)**

July 2017

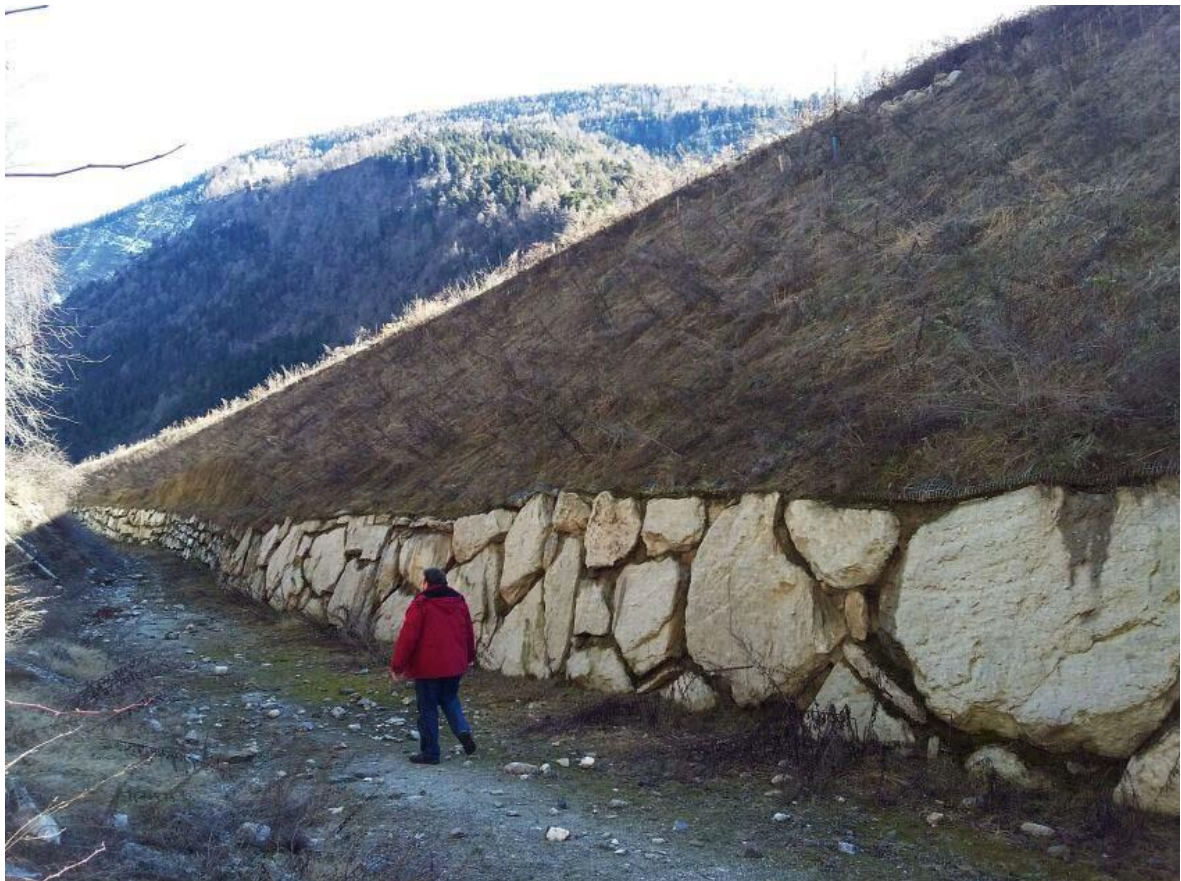
Fig. 1.4: Example of a rockfall protection embankment in Canton Valais with rockery placed in the lower part and soil at the upper part of the uphill slope. The surface roughness of the rockery may be described as smooth and is comparable with the surface roughness in Fig. 1.3a) and c) (Photo: S. Lambert).

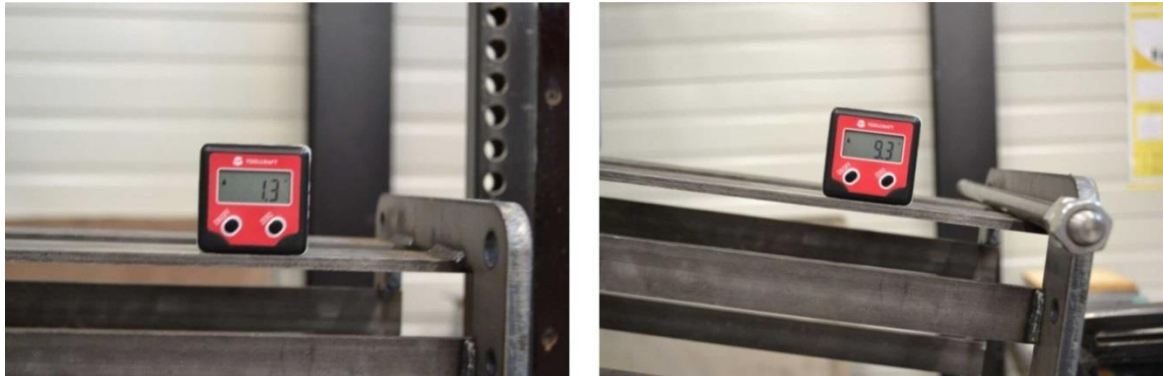
Fig. 2.3: Inclinations of the down pipe exit used in the tests.

For example, a test named OKT\_2121FF\_18\_11 was done with impactor OKT, the embankment cross section was symmetric with a batter of 2:1 on both sides and masonry stones placed horizontally at both slopes. The crest size was approx. 18 cm and the inclination of the down pipe at the exit was  $9.3^\circ$  as shown in Fig. 2.3 on the left.

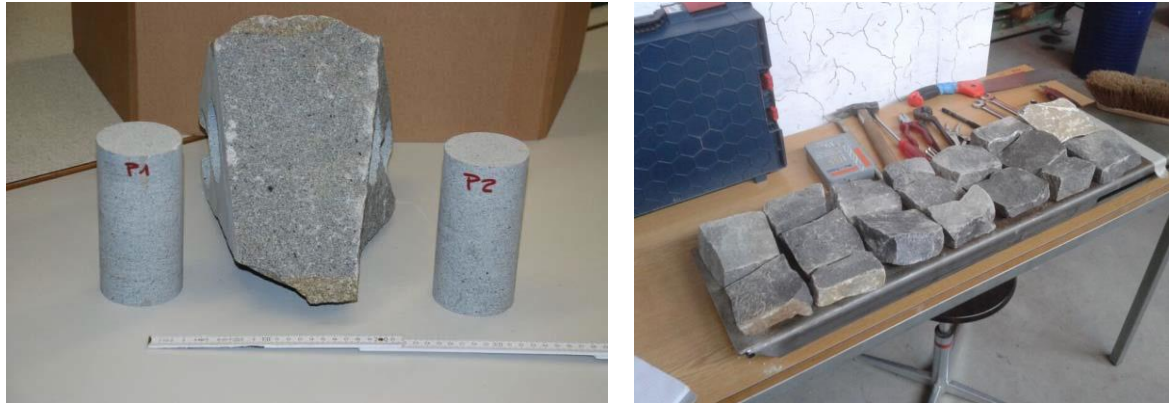
Fig. 2.9: Left: Block of Guber-Quarzsandstein and specimens P1 and P2, which had been used for uniaxial compression test, right: Selected pieces of Guber-Quarzsandstein before placed in the model embankment.

The "rockery" used in the models have been constructed with a local siliceous sandstone called Guber-Quarzsandstein. This material is mined at the stone quarry Guber near Alpnach and shows a real high toughness. To determine the rock density, the static elastic parameters and the uniaxial compressive strength two specimens had been drilled out of a larger block (Fig. 2.9, left). The mean value of the rock density was determined to be  $\rho_{St} = 2617 \text{ kg/m}^3$ . The results of the laboratory tests on the 2 specimens are shown in table 2.2.

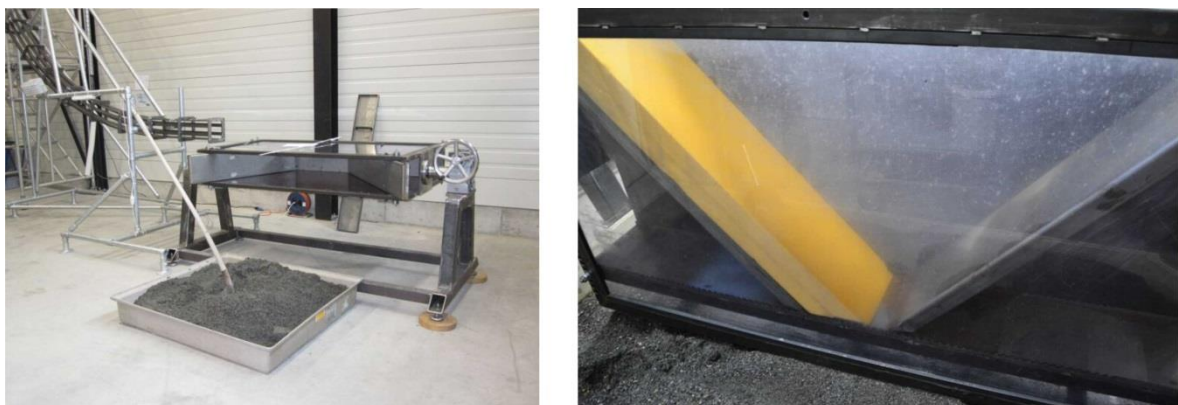
Fig. 2.10: Left hand: Test box in horizontal position with already installed panel sheets. Right hand: Test box in upside down position ready for filling with soil material. Insulating wall panels (in yellow) had been used for varying the crest's dimension without changing the slope inclination.

The geometry of the model embankments was constructed by using two panel sheets, which had been placed inside the box (Fig. 2.10, on the left). To construct the embankment the box was turned upside down (Fig. 2.10, on the right) and the soil and stones had been placed in the box by layers. Every soil layer has been carefully compacted. Joints between the masonry stones have been filled with soil.

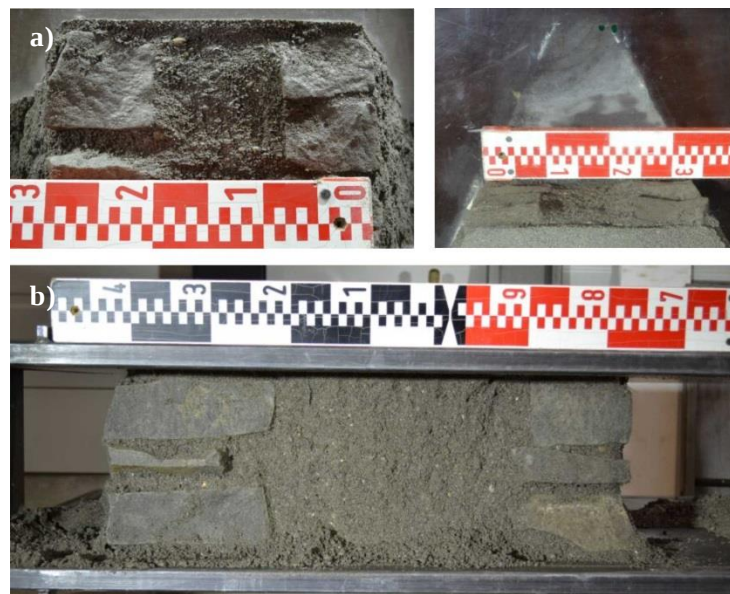
*Fig. 2.16: Proportion of stone and soil layer in horizontal sections: a) at the upper third of the embankment, b) at the bottom of the embankment.*

When the stones had been placed horizontally (see Fig. 2.16), the block punched through the embankment's crest (Fig. 3.10 c). An upward movement of the block can also be seen in case c), but the difference between impact point and maximum trajectory level is less in this test compared with the cases a), b) and d). In addition the trajectory of the block center is running within the contour of the embankment (Fig. 3.10 c). As already mentioned the stones are not able to reduce energy by compaction but transfer the energy to the soil body behind the stones. The soil body behind the stones in this case is smaller than in cases a) and b), that means the resistance of the soil is less than in case a) or b), which ends up in the destruction of the crest.

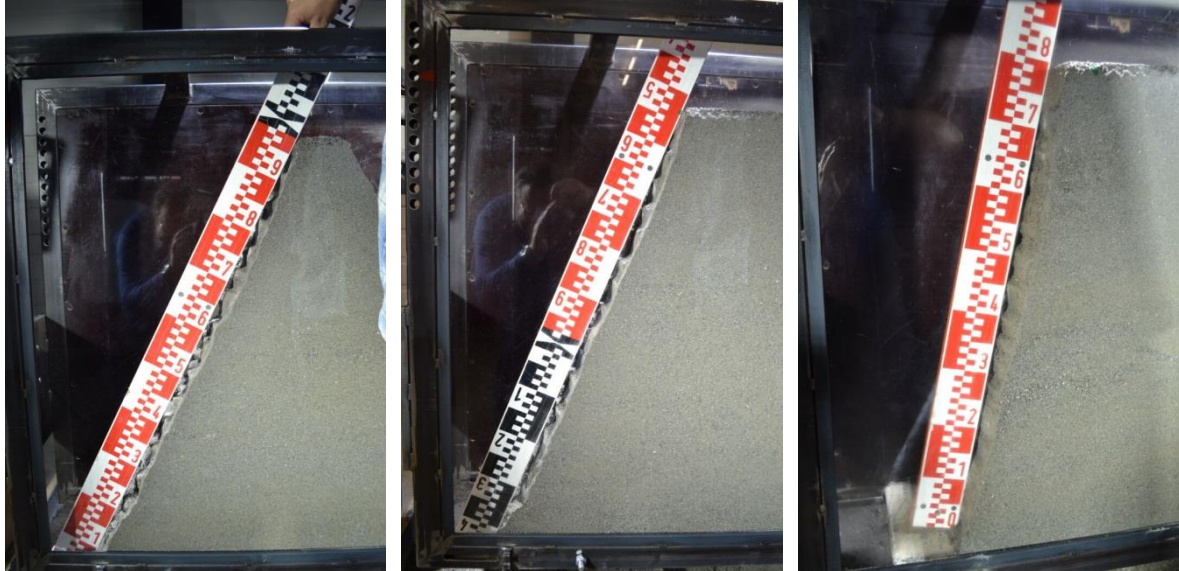
*Fig. 2.17: Roughness of the “rockery” with masonry stones placed horizontally for slopes with batter 2:1, 5:2 and 5:1. The roughness is reduced with increase of slope steepness.*

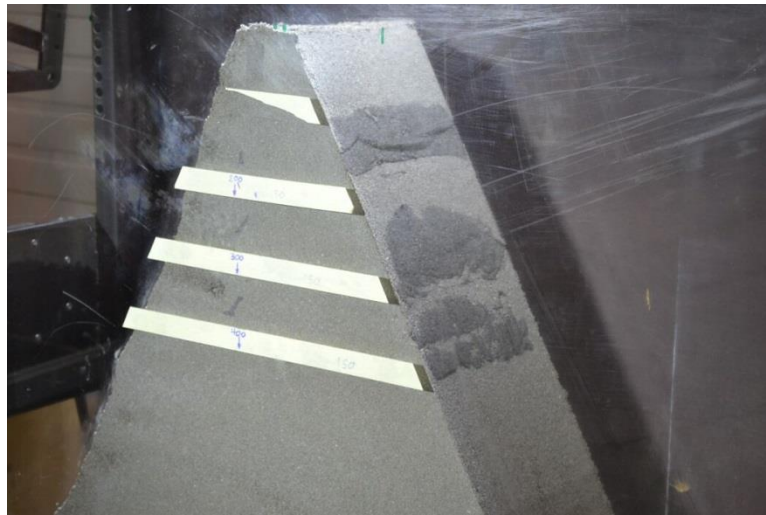
*Fig. 2.18: Model with the “geogrid reinforcement” at the downhill slope.*

For the one experiment, which was done with “geogrid reinforcement” at the downhill slope, a G was added as a fifth part of the name.

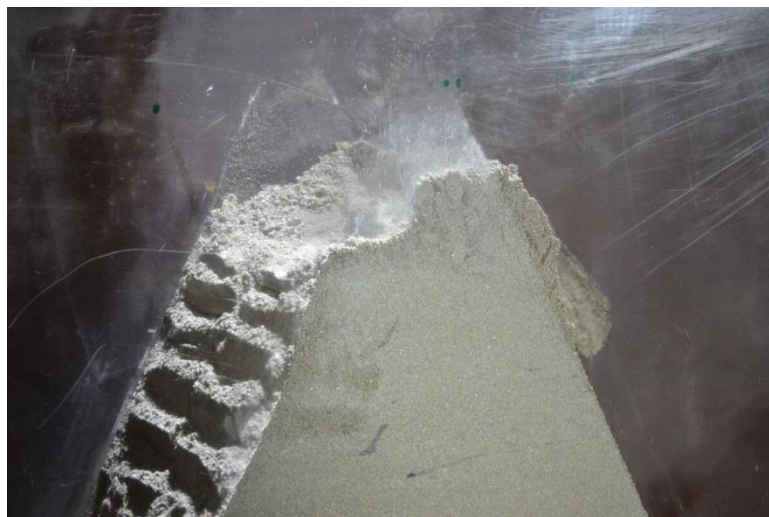
*Fig. 2.19: Bagging of the “geogrid reinforcement” after the impact.*

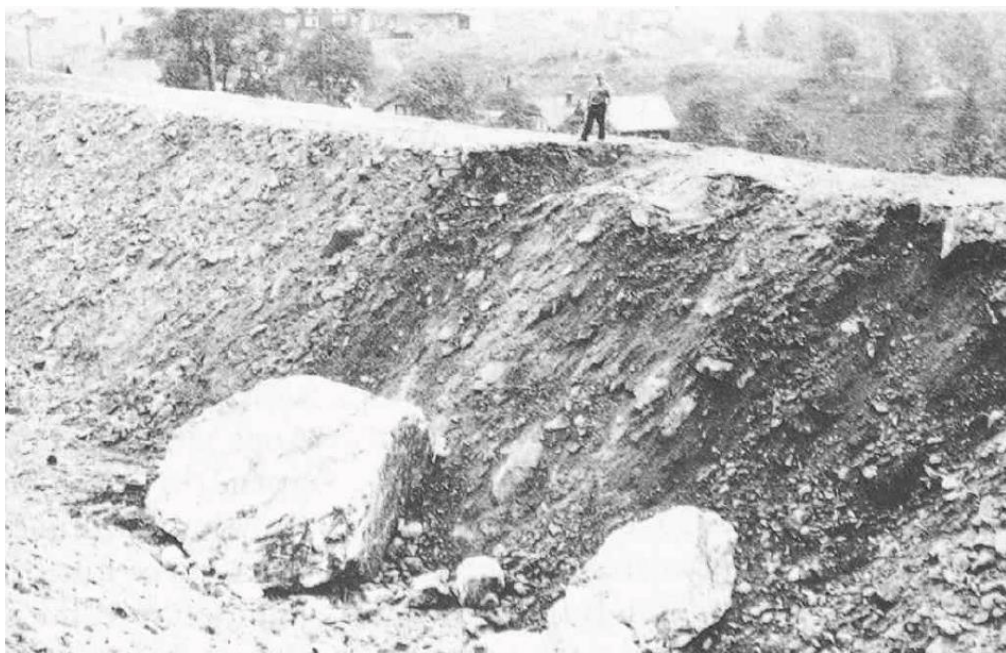
*Fig. 4.2: Impact at the embankment Halteli-Talmatt, Canton Uri. The embankment was neither punched through nor surmounted, but the impacting block reached the crest (Schneider, 1984)*

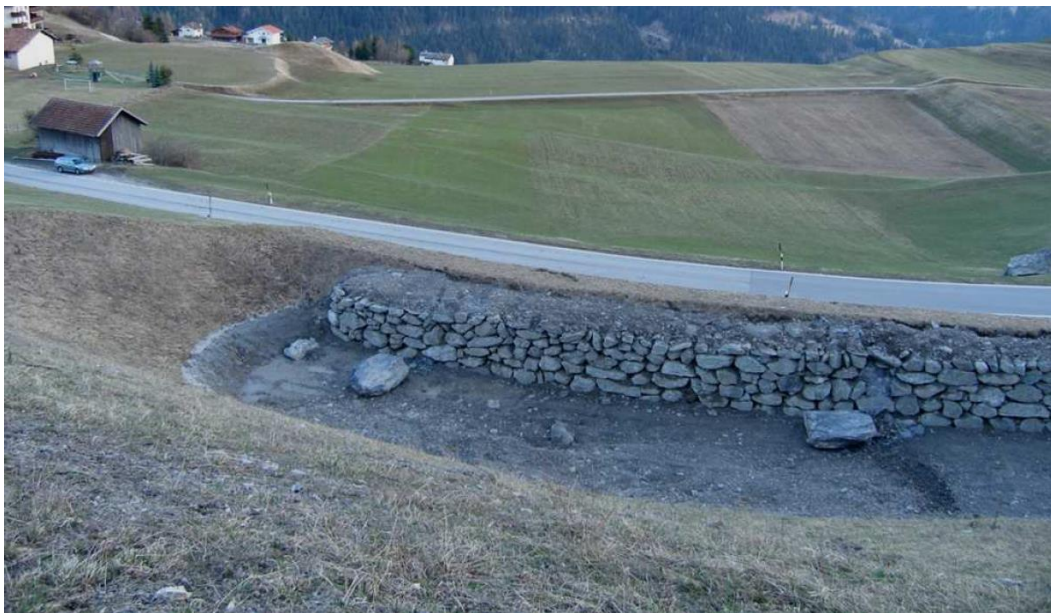
*Fig. 4.3: Impacts of two blocks ( $4 \text{ m}^3$  resp.  $6 \text{ m}^3$ ) in 2011 at embankment Gretla after redesign and implementation of rockery at the uphill slope (Photo: Tiefbauamt Graubünden). The rockery showed only minor damage.*

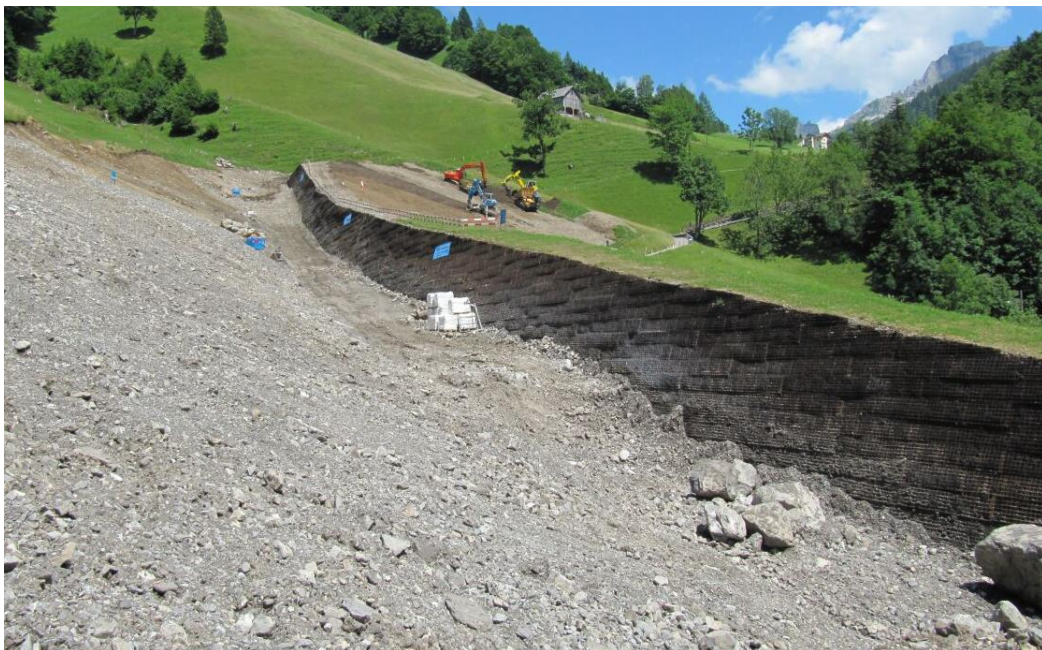
*Fig. 4.4: Embankment Riemenstalden, Canton Schwyz, constructed with geogrid reinforcement, (Photo: B. Kister, 2015)*

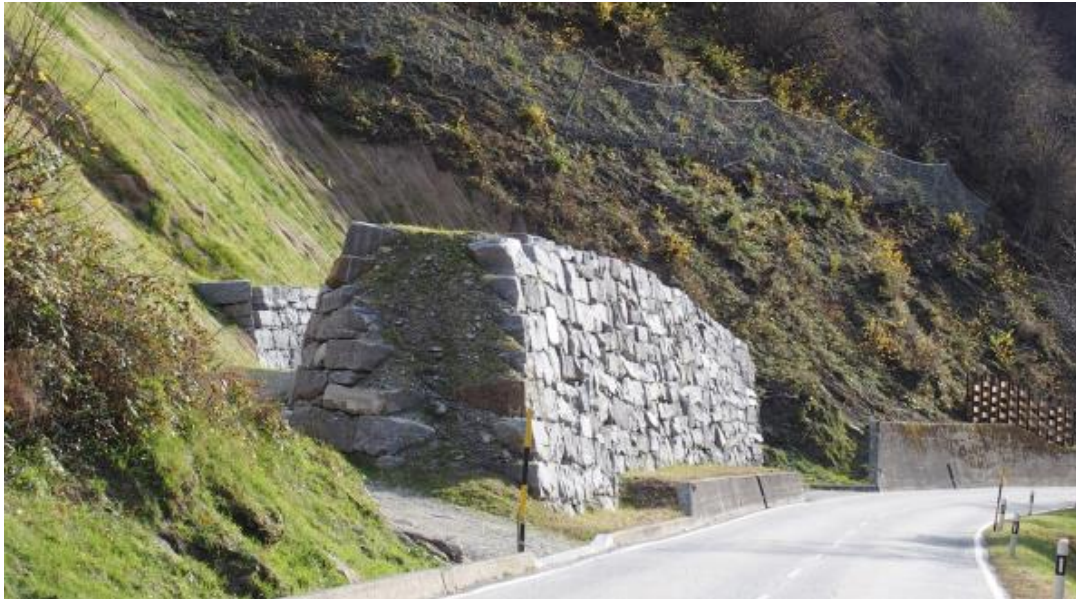
Fig. 4.6: Embankment Botegeh, Canton Grisons, 2015 (Photo: Tiefbauamt Graubünden)

Sometimes in Switzerland rockfall protection embankments had been constructed with rockery on both slopes. As an example embankment Botegh, Canton Graubünden, is shown in Fig. 4.6. The reason for this type of construction very often is a very limited space for the construction of an embankment as shown for example in Fig. 4.6.

Some tests with model embankments of this type had been executed in the project AERES and the test results showed a probability for secondary rockfall at certain circumstances. Because no compression work will be done at the stones of the rockery, so these stones act approximately like a Newton pendulum and transfer the impact energy directly towards the soil behind the rockery. If the volume of soil between the two stone walls is small, the capability to dissipate energy by compression is very limited and a high quota of energy is transferred to the downhill rockery and may cause secondary rockfall (Fig. 4.7). The problem may be reduced, if the soil volume between the two stone walls has a horizontal extent of more than one block diameter (Fig. 3.13 d).

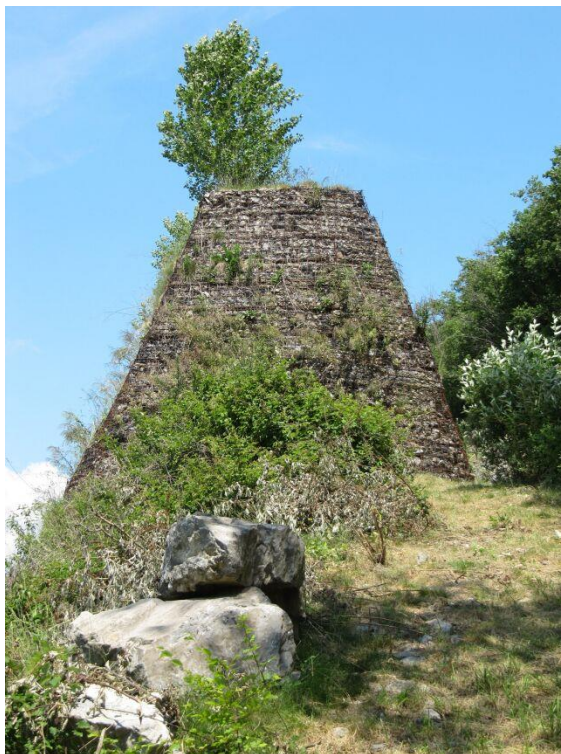
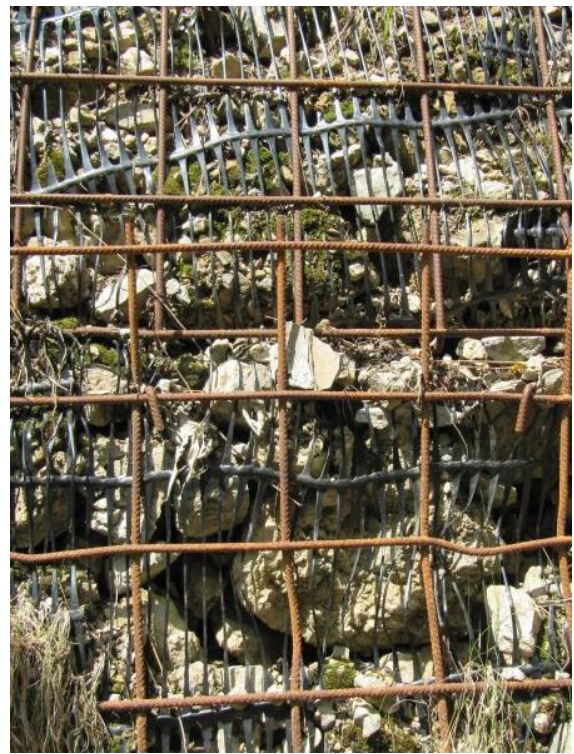
Fig. 4.9: Example of an embankment constructed with geogrid reinforcement on both slopes nearby Lecco, Italy (Photos: B. Kister).

To avoid the problem of secondary rockfall and construct nevertheless steep slopes at the downhill side of the embankment a construction with geogrid reinforcement is suggested. Such a construction prevents the downhill slope to act as a free boundary because the geogrids will bind back the embankment's soil material (see tests of Peila et al., 2007). Examples of such a construction with geogrids are shown in Fig. 4.8 and Fig. 4.9. With the existing experimental set-up it was not possible to do tests with such a type of embankment, because the lateral fixing of geogrids in a quasi-2D-model is not possible.

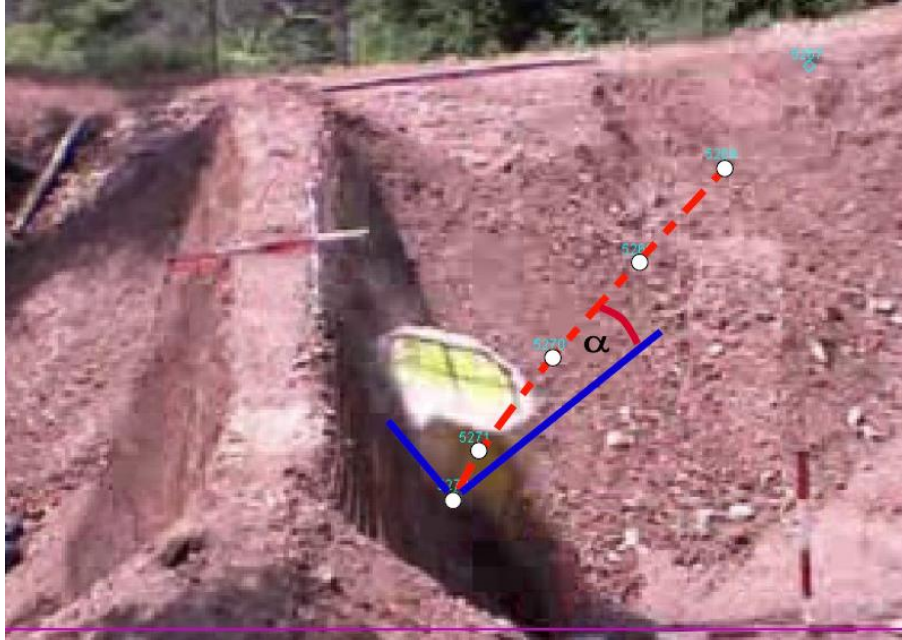
*Fig. 4.11: Full size test done by Peila et al. (2007). Result of an analysis with the program Tracker of a movie presented by Tenax Geosynthetics. The test shows a negative impact angle.*
