> Seismic retrofitting of structures

Strategies and collection of examples in Switzerland

Wenk T. 2008: Seismic retrofitting of structures. Strategies and
collection of examples in Switzerland. Environmental studies No. 0832.
Federal Office for the Environment, Bern. 84 pp.

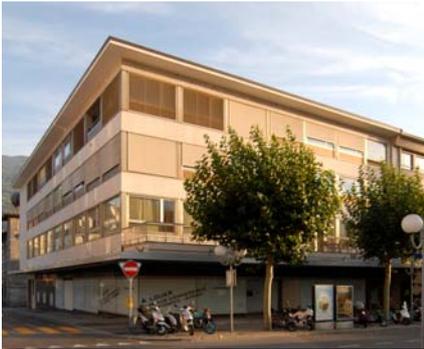
Building with horizontal weak ground floor (Example 5: residential and retail shop in Sion)

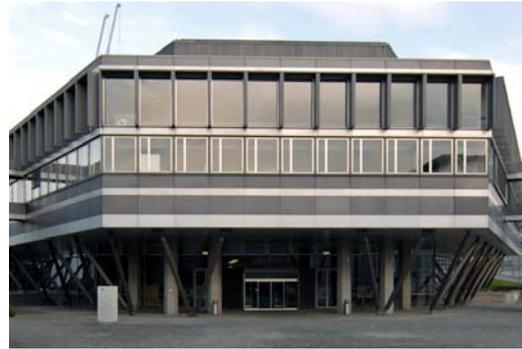
Building with unsymmetrical bracing (Example 15: auditorium at ETH Zurich)

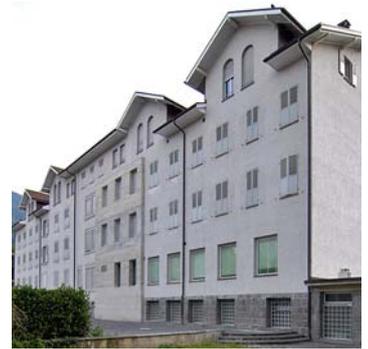
Building with unreinforced masonry (Example 7: school in Monthey)

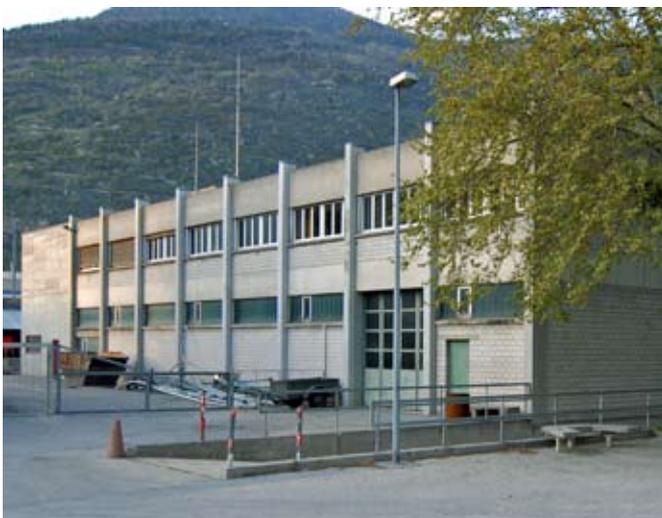
The longitudinal facade of the rear of the fire station stiffened by the reinforced concrete structural wall at the left end.

The critical gable wall at the south end will be strengthened by post-tensioning 8 CFRP-strips bonded to the inside of the wall. The CFRP-strips are anchored at the roof and the reinforced concrete slab of the first floor. Due to the post-tensioning, the gable wall can carry the earthquake action by small

horizontal deformations respecting the damage limitation criteria for a building of importance class IC III. In addition, the post-tensioned CFRP-strips prevent the out of plane toppling of the wall.

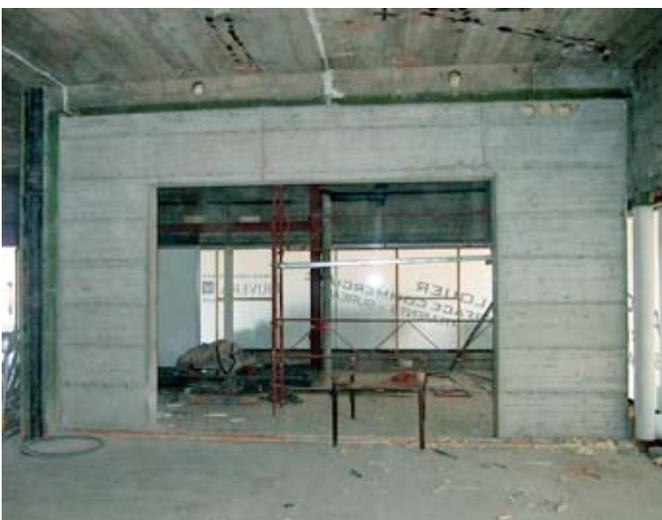
The structural system is highly irregular in both the floor plan as well as in elevation. Because of the large area of retail space needed at the ground floor, most of the bracing elements are missing. Under seismic actions the ground floor level forms a classic soft storey with torsion.

The building was strengthened by a new reinforced concrete core and a reinforced concrete wall both running through all of the upper storeys. The ground floor was further stiffened through a massive reinforced concrete frame. The new structural elements were anchored in the basement.

New reinforced concrete frame in the ground floor level.

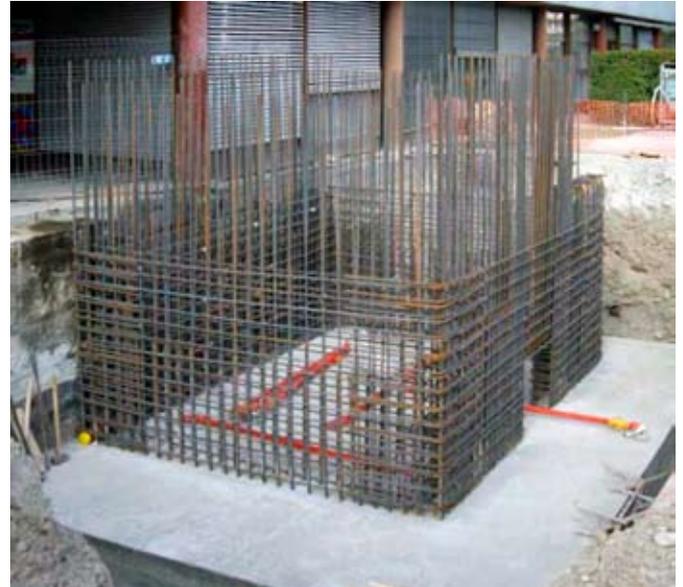
Steel reinforcement in the basement and foundation of the new stairway towers.

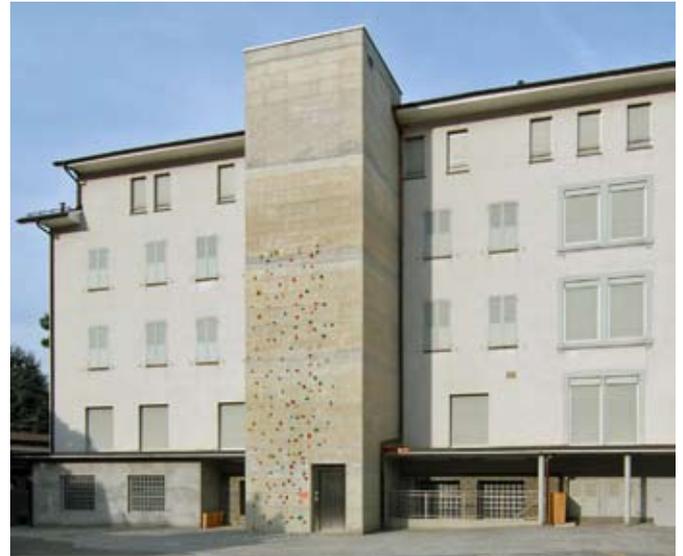
View of the rear facade with the new reinforced concrete elevator shaft.

The newer portion of the building was strengthened by new reinforced concrete walls on both longitudinal sides. The new walls run throughout all the storeys of the building. In the first stage of the work, an elevator shaft was constructed on the rear side of the building, primarily to ensure bracing in the transverse direction. To resist the overturning moments, the foundation of the elevator shafts was secured to the foundation soil with twelve micropiles. In the second stage of the work, the front facade was supplemented by a rectangular reinforced concrete wall acting together with the elevator shaft to brace the building in the longitudinal direction. In the older portion of the building, anchorages between the facades and the wooden floors were installed.

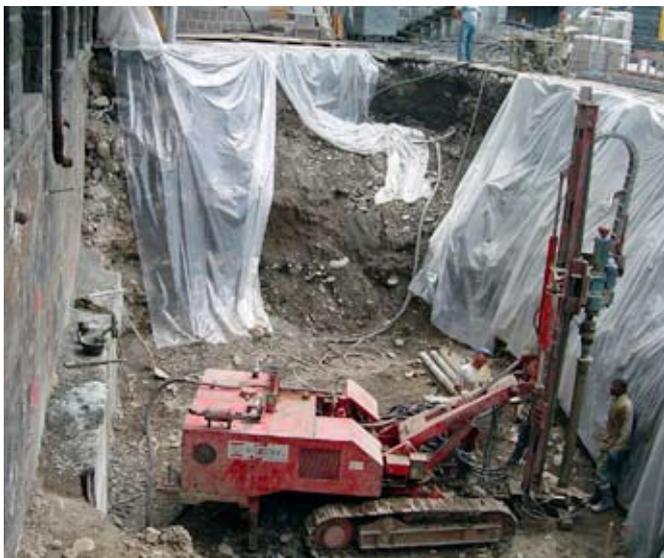
Construction of the foundation of the new reinforced concrete elevator shafts with micropiles.

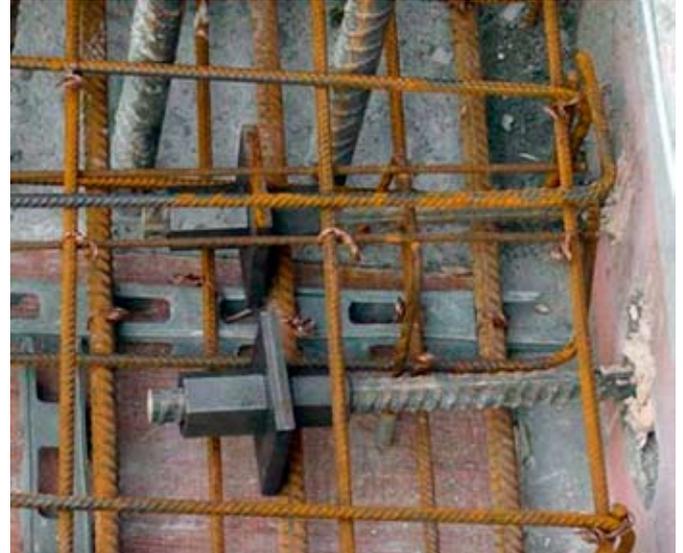
Anchorage of the elevator shaft with Swiss-Gewi rods and grouted reinforcement in the existing reinforced concrete floors.

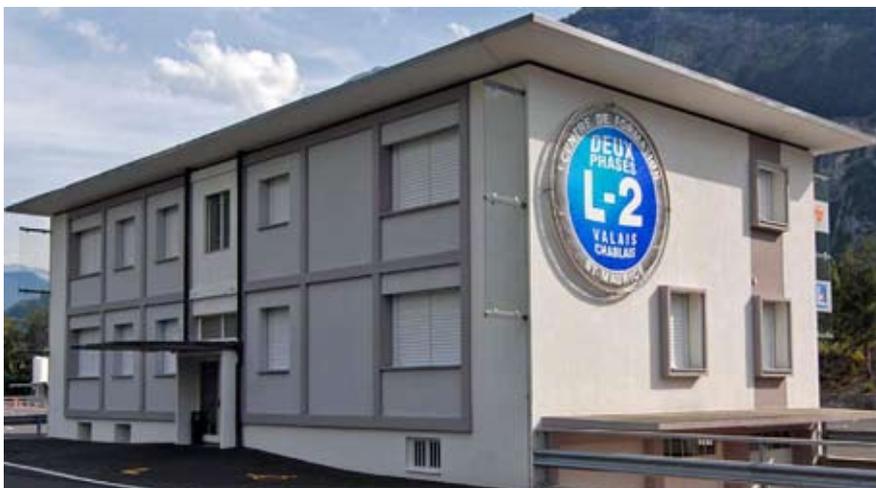
View of the rear longitudinal facade with the new reinforced concrete structural wall in the middle middle at the right.

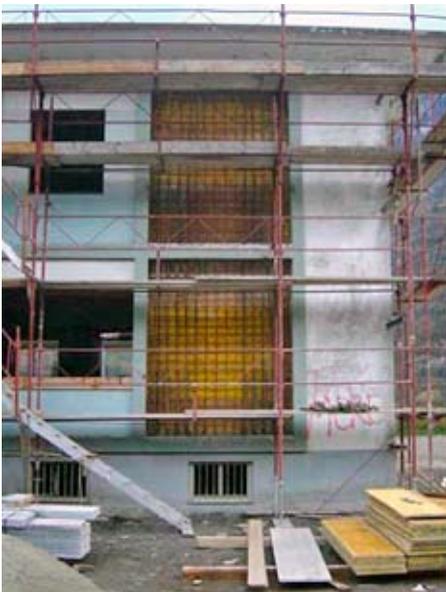
Reinforcement of the new concrete structural wall in the front longitudinal facade.

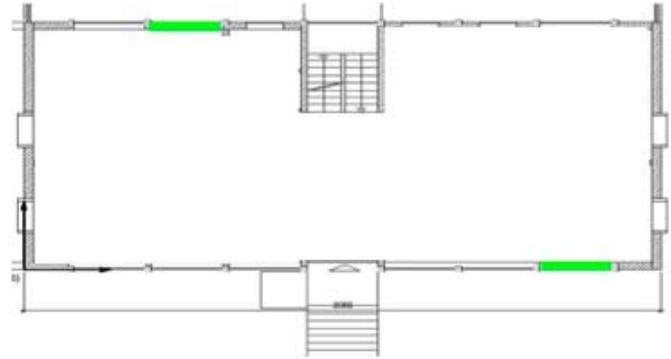
Floor plan showing both new reinforced concrete structural walls (green) in the longitudinal direction.

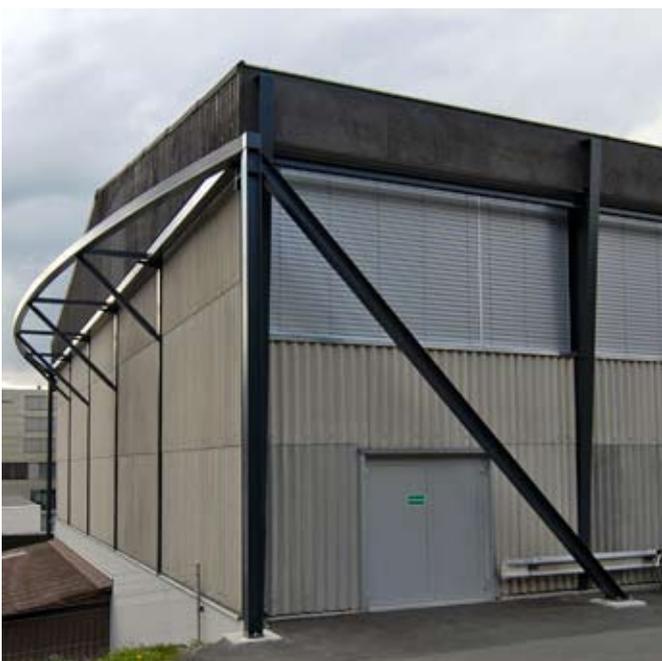
Fish-belly shaped reinforcement in the end facade columns.

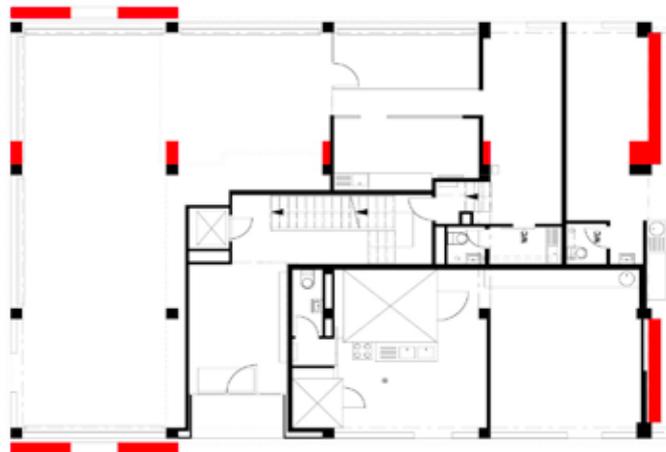
Floor plan of the ground floor level with the new reinforced concrete walls (Lateltin 2003).

The plan was for the building to receive a new structural system for horizontal actions in both principal directions in plan consisting of two, slender reinforced concrete walls extending through all storeys. The new walls are anchored on micropiles in the foundation soil.

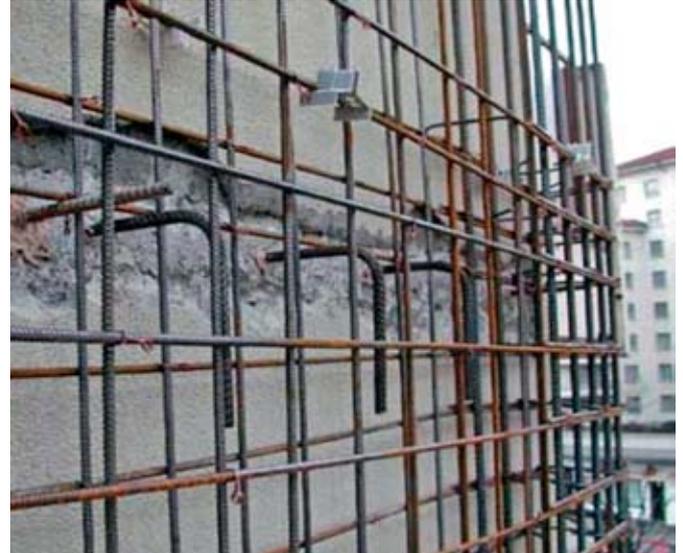
Reinforcement detail of the new concrete structural wall with grouted dowels in the existing floors.

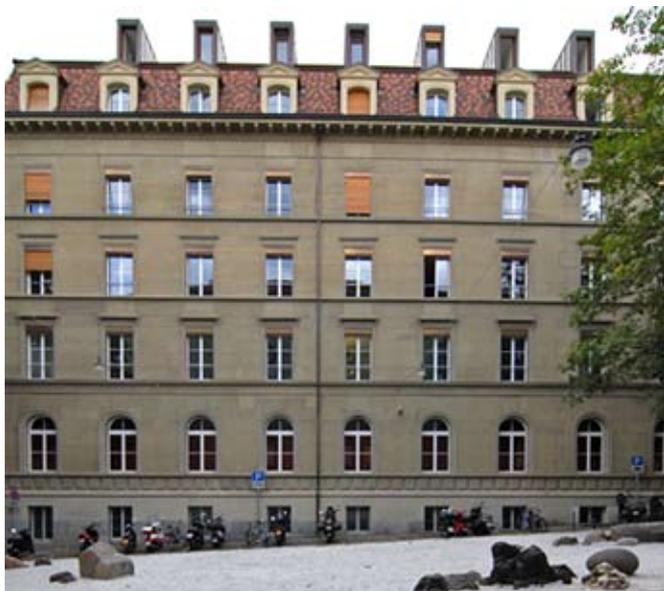
The timber beam floors and the natural stone masonry walls form the structural weakness relating to seismic performance. The transfer of horizontal force from the timber beam floors in the walls is particularly insufficient. Some of the walls are interrupted in the ground floor. In addition, for some walls the out-of-plane stability is critical.

View of the east facade.

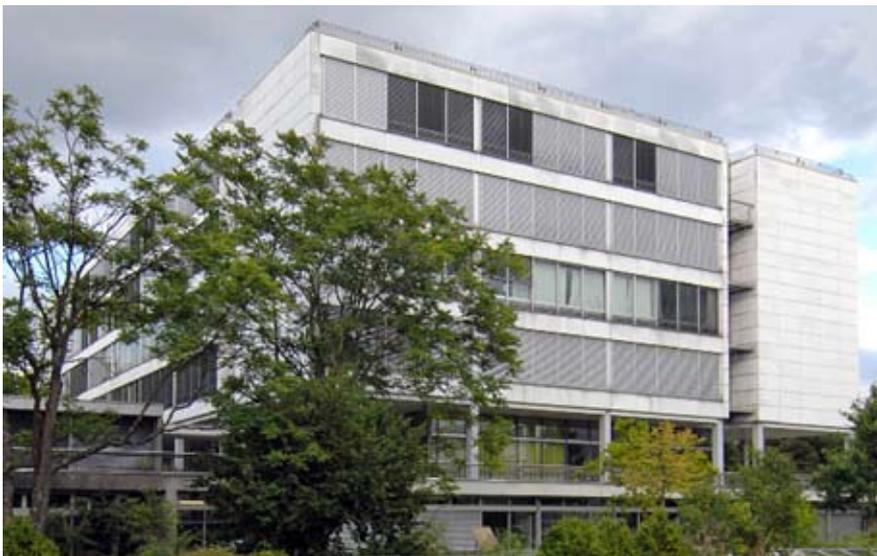
View of the end facade of the building.

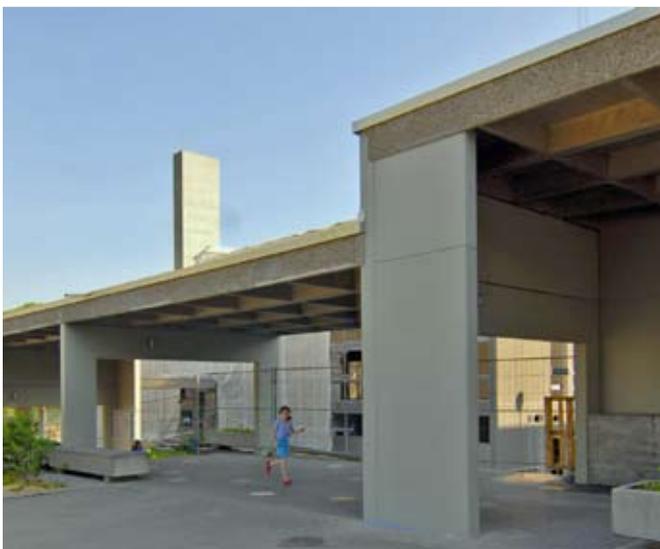
The connecting walkway was retrofitted through the reinforced concrete walls in the longitudinal direction.

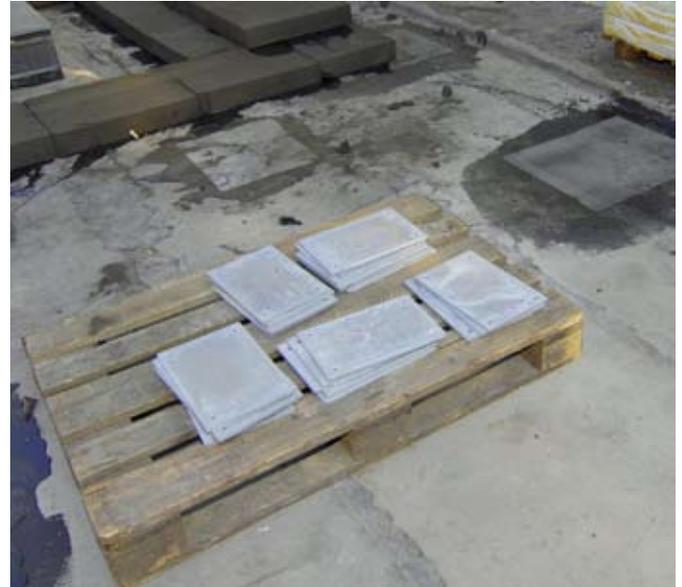
Steel plates for the connections of the roof elements.

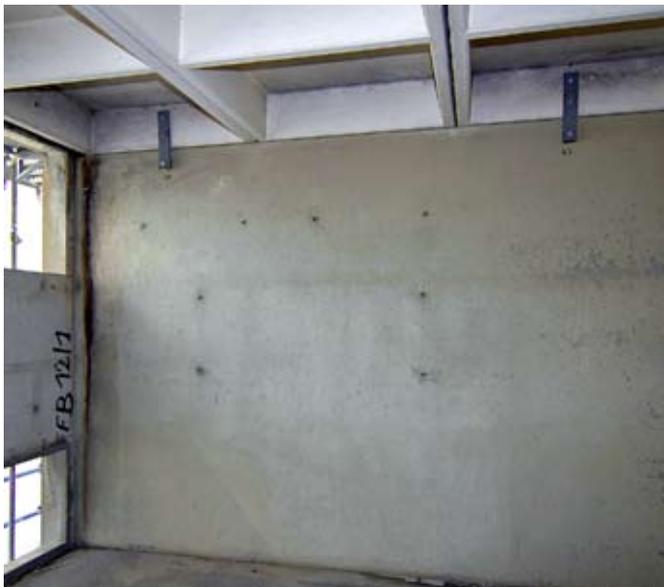
Additionally installed steel straps for the connection of the coffer slab with the walls.

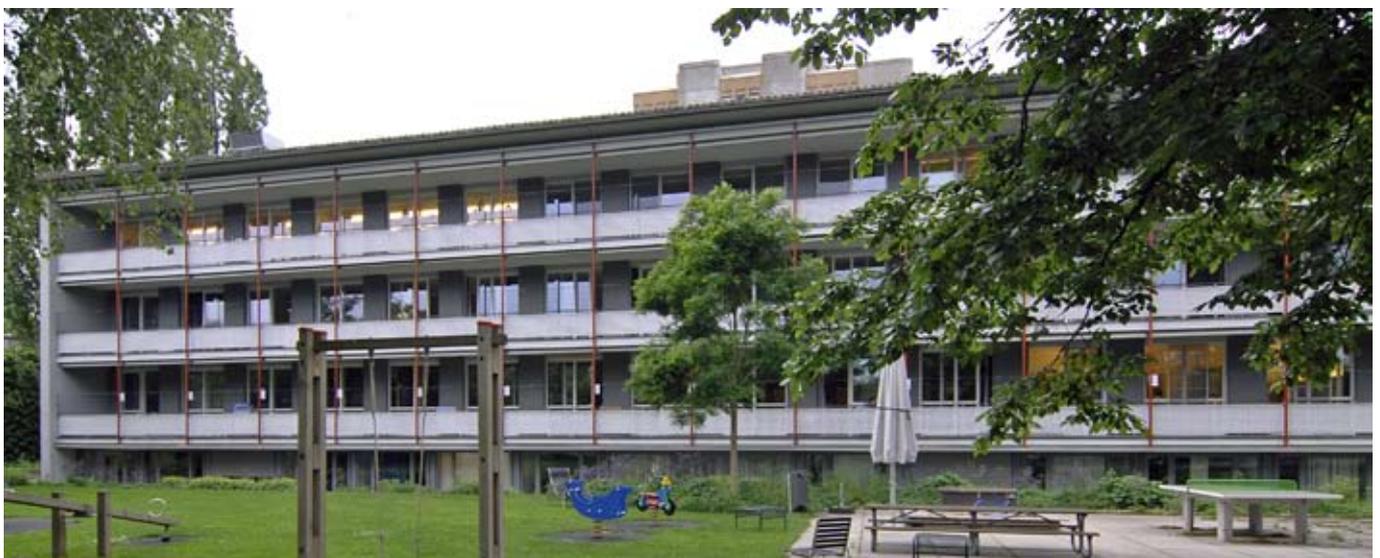
View of the longitudinal facade on the playground side.

In the longitudinal direction, two new reinforced concrete walls running through all storeys were added, one of which will be constructed as a particularly ductile, coupled wall. For the bracing in the transverse direction, a 5.2 m long and 28 cm

thick wall was concreted on both existing masonry gable walls. A third reinforced concrete wall was placed in the middle of the building in order to reduce the forces on the long floor slabs.

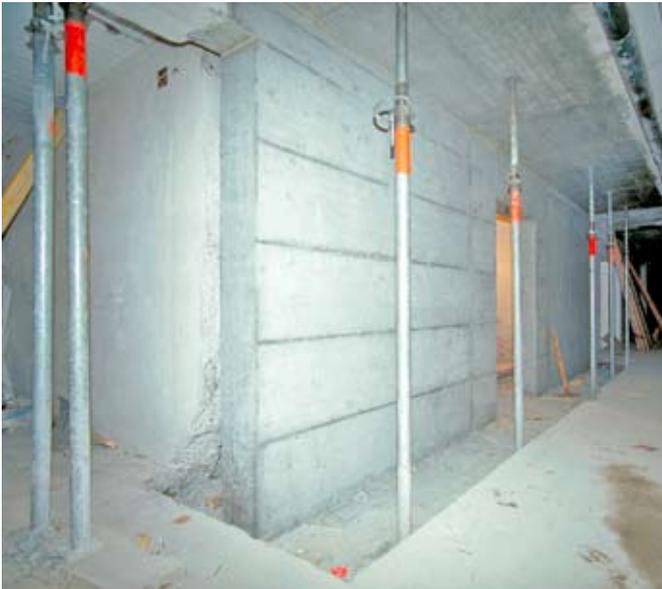
New coupled reinforced concrete structural walls in the basement.

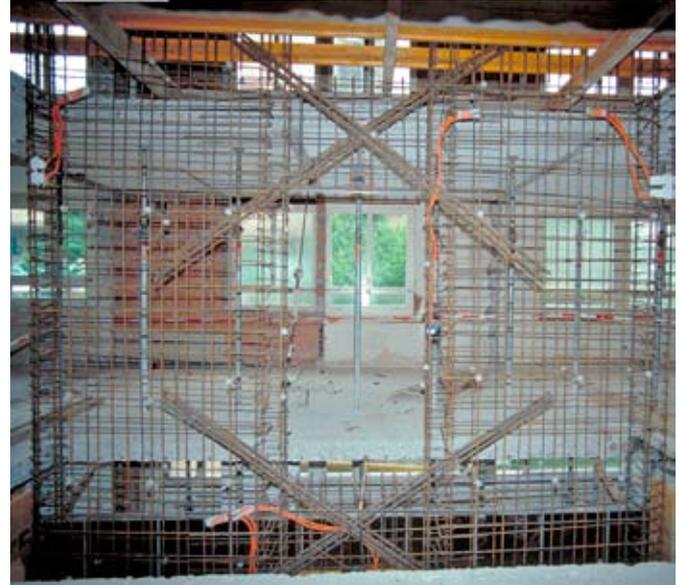
Reinforcement of the new coupled reinforced concrete structural walls in the ground floor level with diagonal bundled bars in the coupling beams.

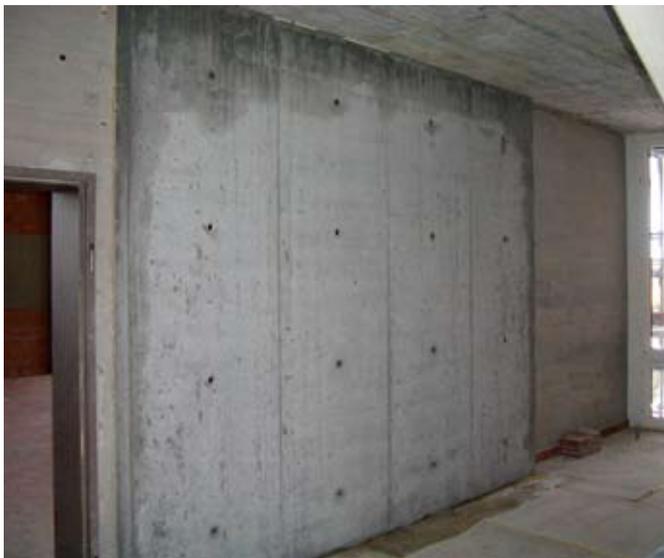
The existing reinforced concrete walls in the staircase have too little vertical and horizontal reinforcement. There is no bracing in the roof level over the staircase. The reinforced concrete roof level rests on pendular columns. The masonry walls in the extensions are interrupted through the rows of windows and can carry practically no horizontal loads.

Strengthening of an existing reinforced concrete wall with a 15 centimetre thick double wall.

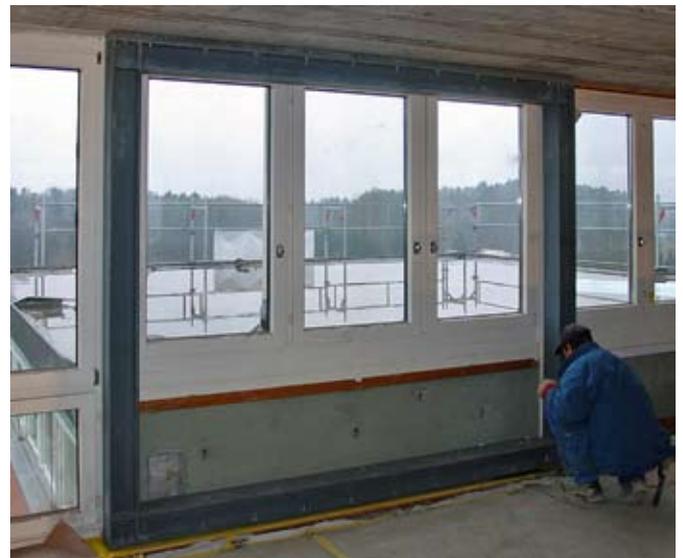
Bracing the roof level with new steel frames.

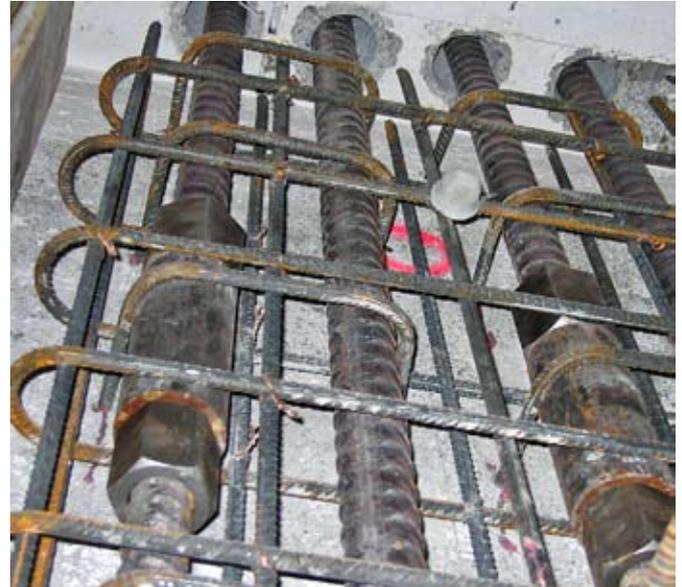
Detail of the vertical reinforcement couplers in the double wall.

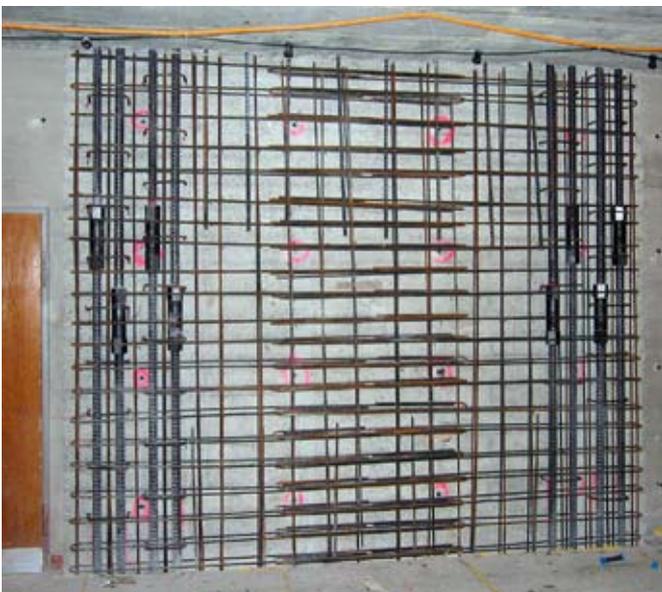
Reinforcement in the composite wall with vertical reinforcement couplers.

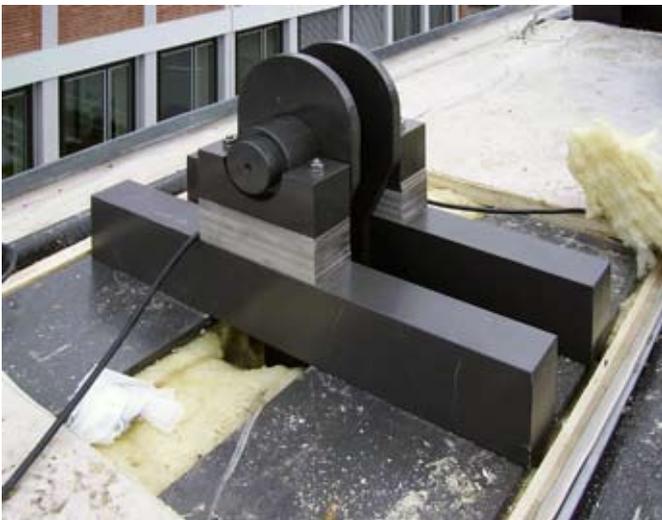
Upper anchorage of the carbon fiber tension rod on the roof from where the post-tensioning occurs.

The northern end facade, a 22 cm thick masonry wall, was strengthened by five 13 m long tension rods positioned on the outside. This was the first time that tension rods reinforced with carbon fiber were applied for seismic retrofitting (Bachmann 2007b). The eccentrically acting vertical post-tension force was transferred centrally to the end facade by means of a steel construction on the roof.

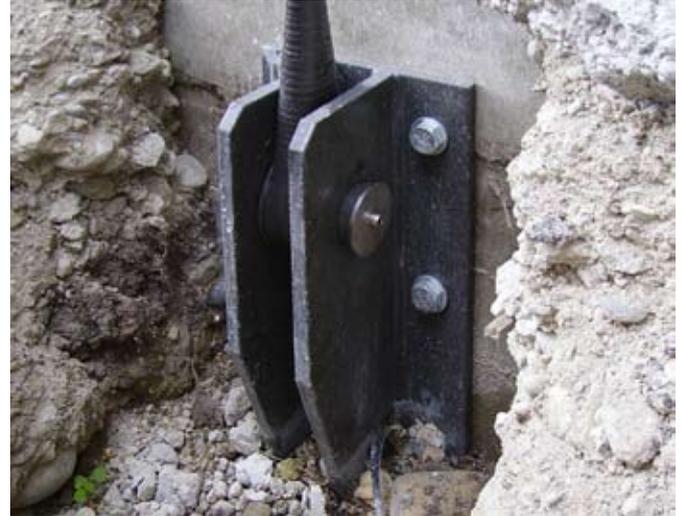
Lower anchorage of the carbon fiber tension rod on the side of the basement wall.

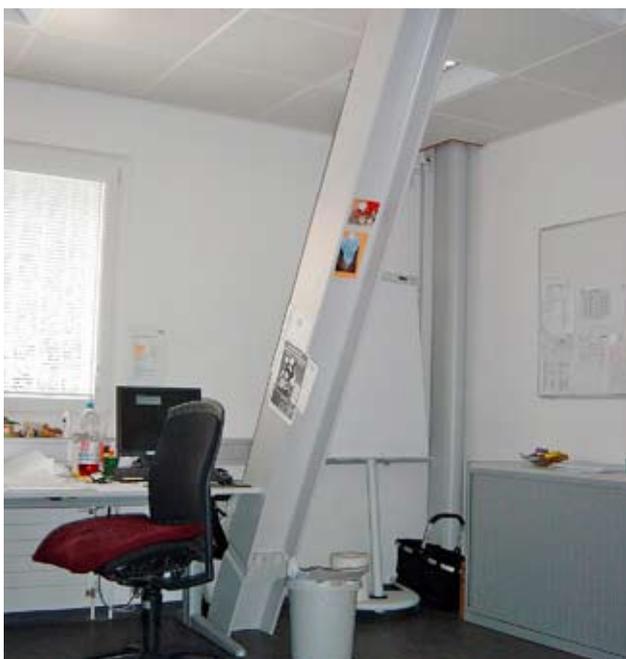
The building exhibits a pronounced soft storey in the ground floor with large torsional effects under seismic action. In addition, there is an expansion joint in the middle of the building's length with adverse effects on the seismic behavior. During earlier reconstructions several walls in the ground floor were removed so that no actual bracing system exists anymore.

New V-shaped steel truss in an office room on the ground floor level.

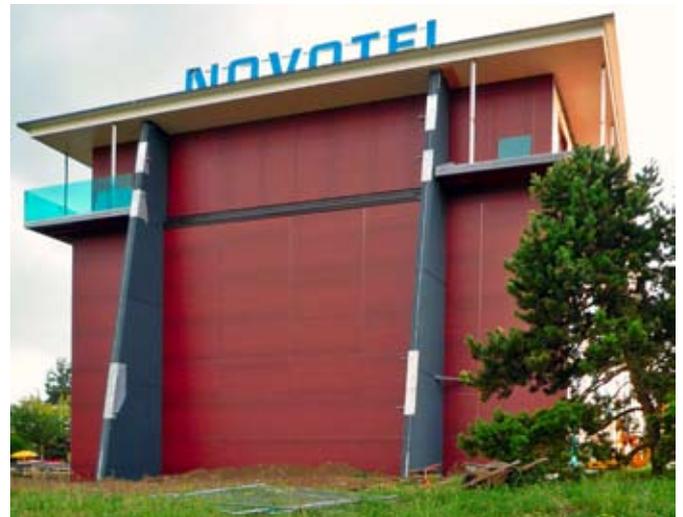
Originally the building had no bracing system in its longitudinal direction, whether for wind or for earthquake. In addition, the subdivision of the building into four compartments through expansion joints, which ran the whole height of the building, resulted in an unfavorable seismic behavior. Furthermore, the suspension of heavy facade elements made of prefabricated concrete was inadequate. In the building's transverse direction, sufficient walls rest on strip foundations.

End facade on the south side with the new triangular reinforced concrete walls.

Both end faces of the building were stabilized through outside bumpers in the longitudinal direction. This was done on the south side by two new triangular reinforced concrete walls and on the north side by a new reinforced concrete staircase. The new bumpers are founded on piles. The existing three expansion joints in the reinforced concrete floors were ceased by expansive mortar. Furthermore, the suspension of the facade elements was strengthened.

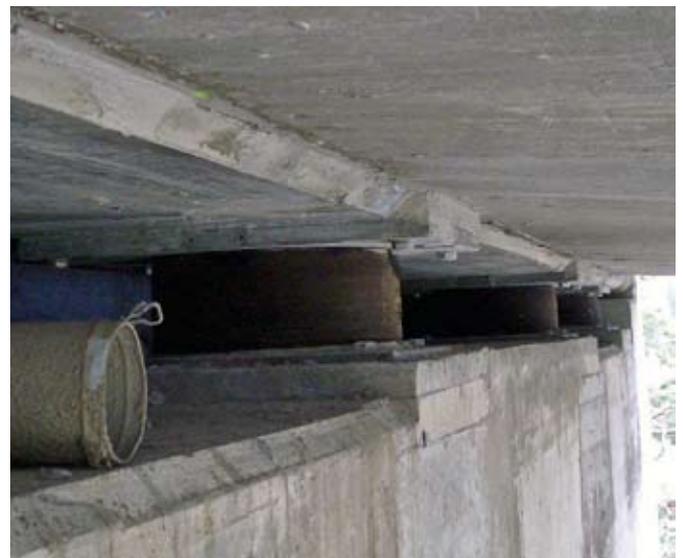
In its initial state, the fixed longitudinal bearings at the abutments of each half of the bridge cannot carry by far the seismic forces. The large variation in column heights causes an irregular distribution of transverse stiffness with the result that the very short columns are overstressed in the transverse direction. Furthermore, there is danger of span unseating in the longitudinal direction at the expansion joint of the intermediate column.

Seismic retrofit with high damping rubber bearings at the abutment.
